January 31, 2020

100 International Drive, Suite 152, Portsmouth, NH 03801
Tel: 603.431.3937

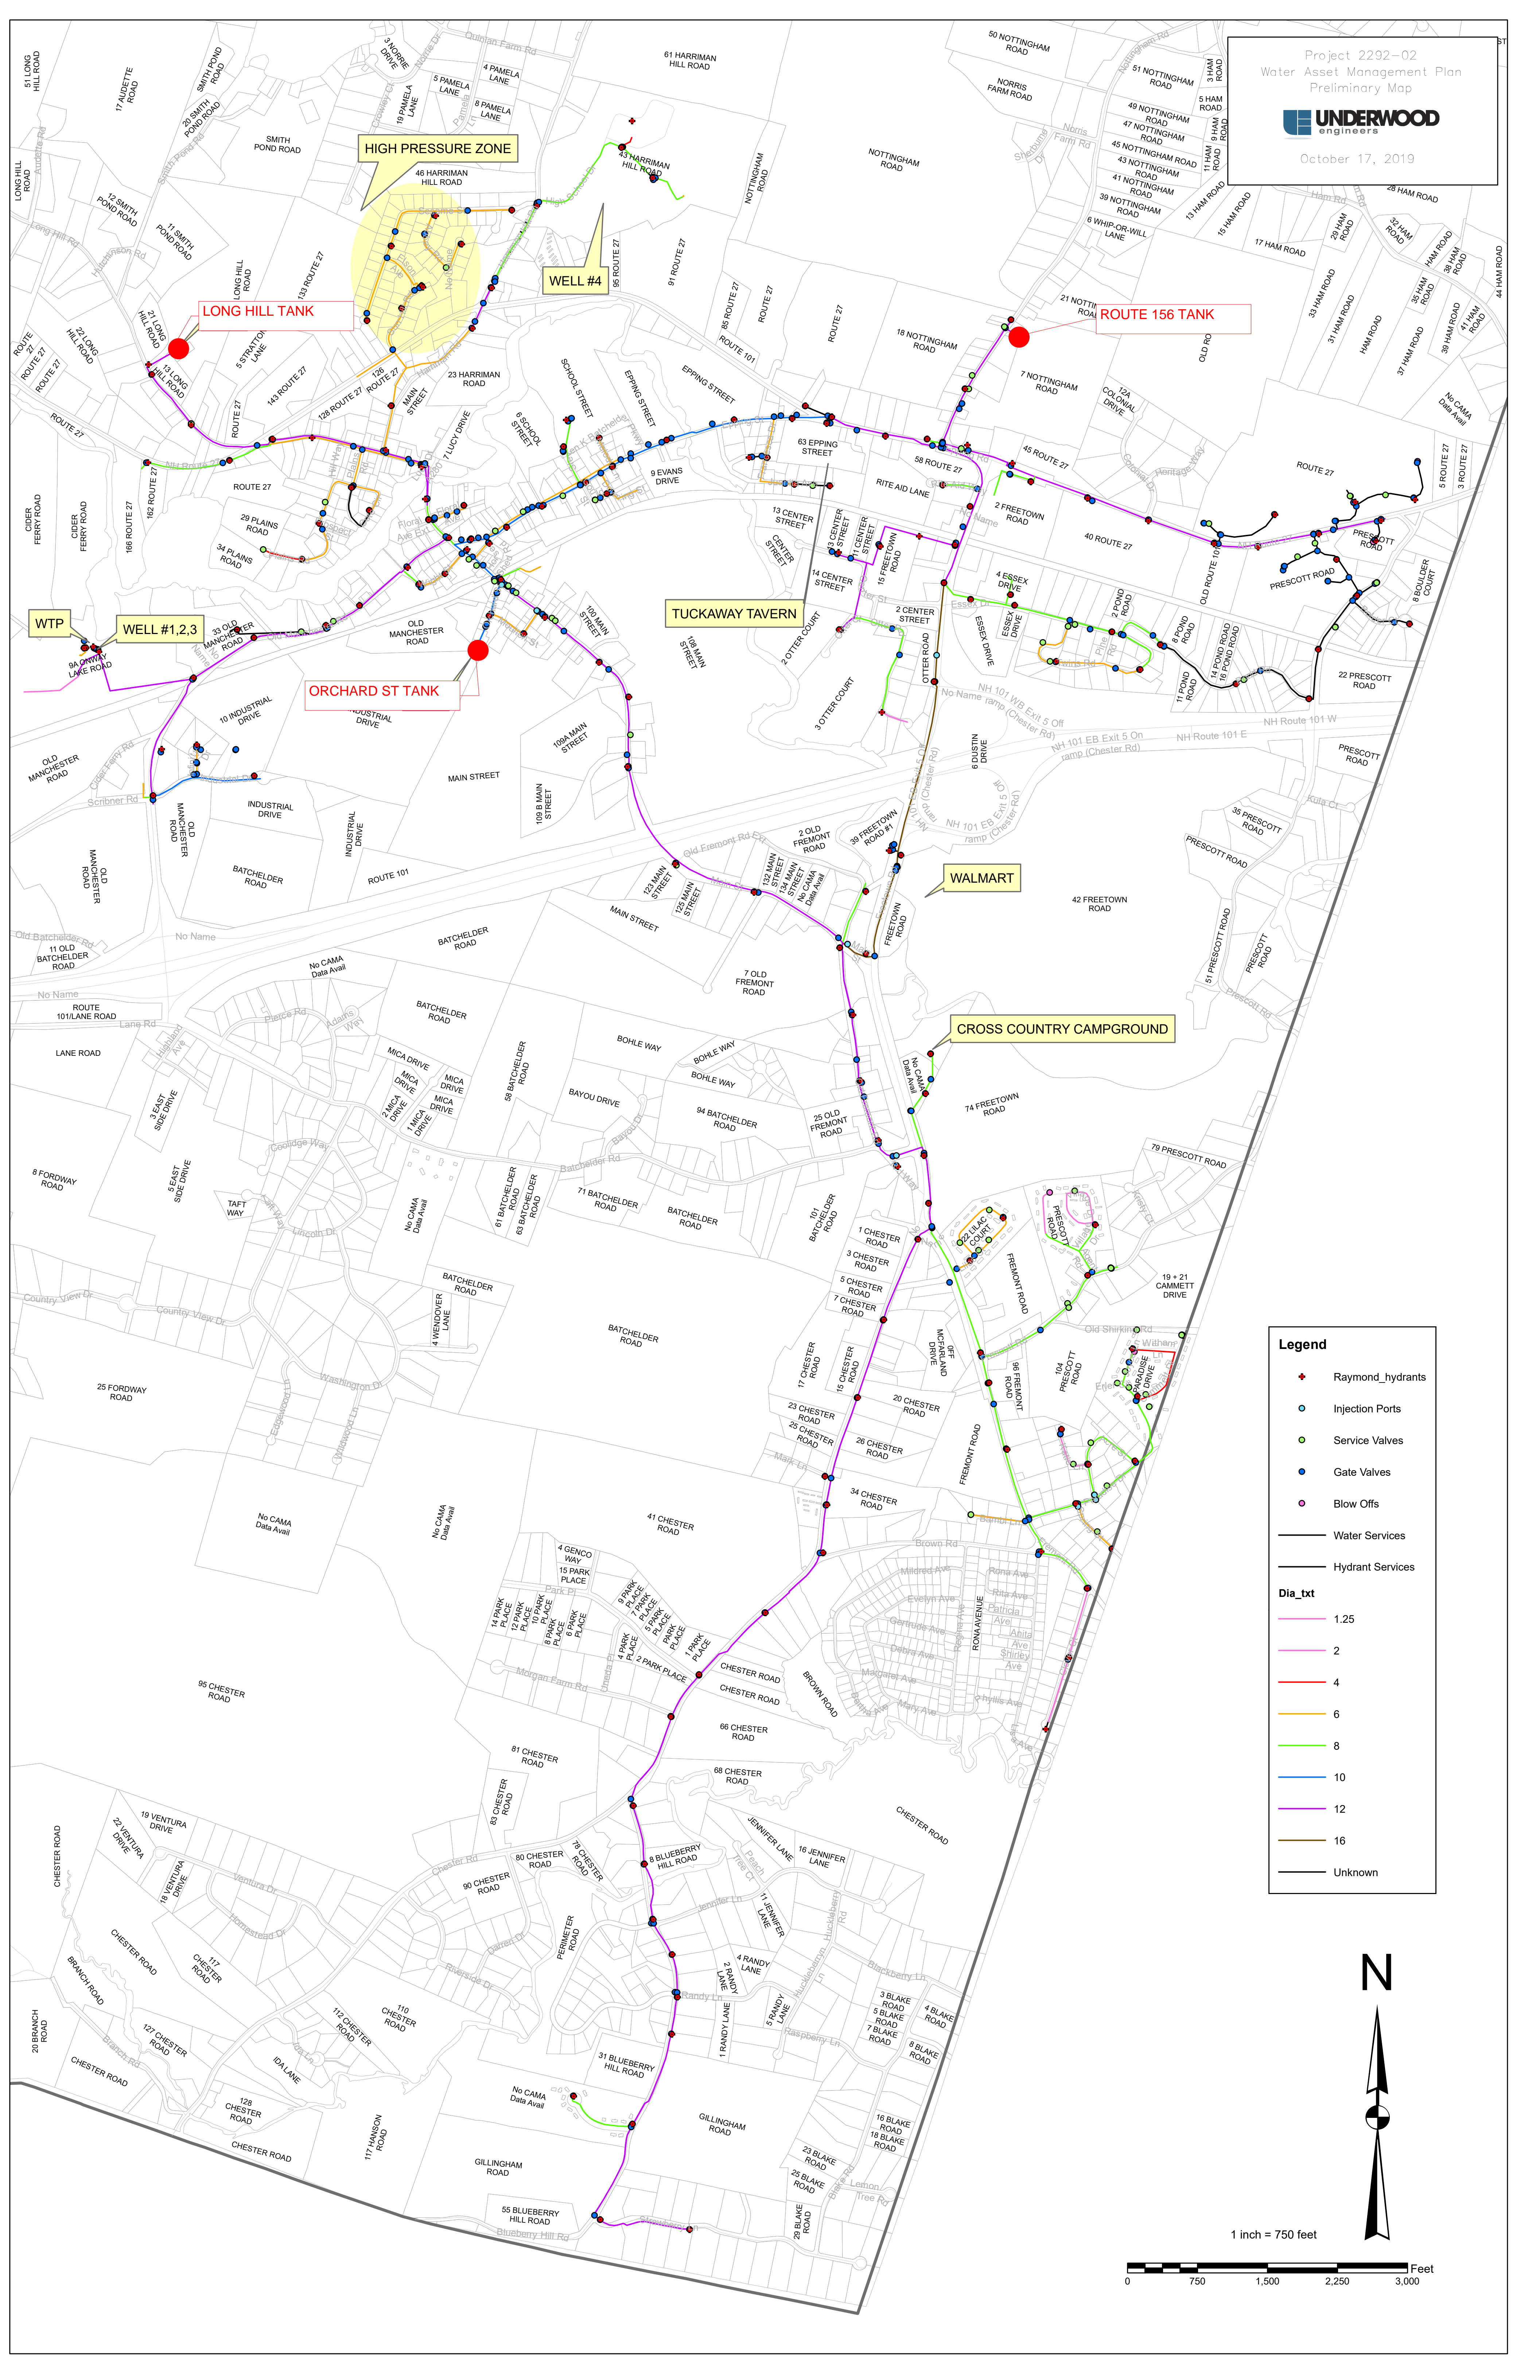
- Attachment A – Distribution System Map
- Attachment B – Itemized Rehabilitation and Replacement Costs
- Attachment C – Storage Tank Inspection Reports

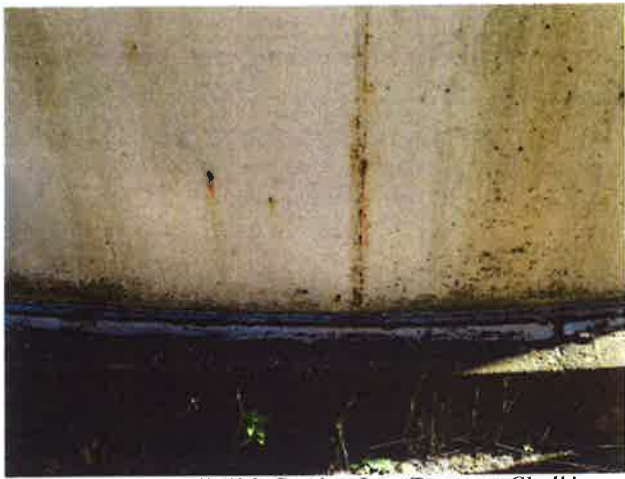
1 *Exterior Wall With Coating Loss/Damage, Chalking Exposed Underlying Steel, Mild Surface Corrosion, Mildew And Corrosion Staining*

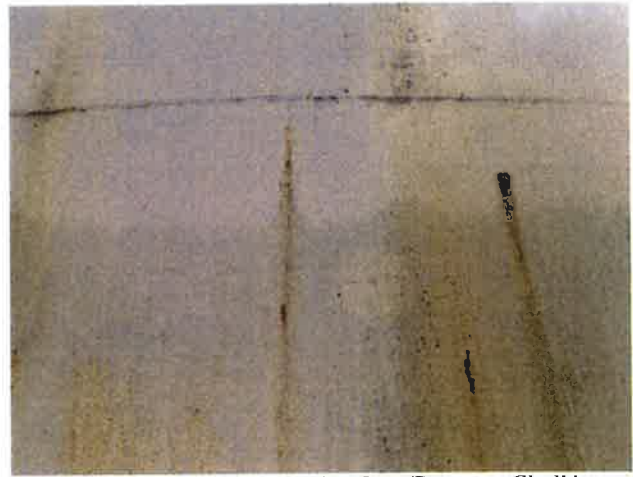
2 *Exterior Wall With Coating Loss/Damage, Chalking Exposed Underlying Steel, Mild Surface Corrosion, Mildew And Corrosion Staining*

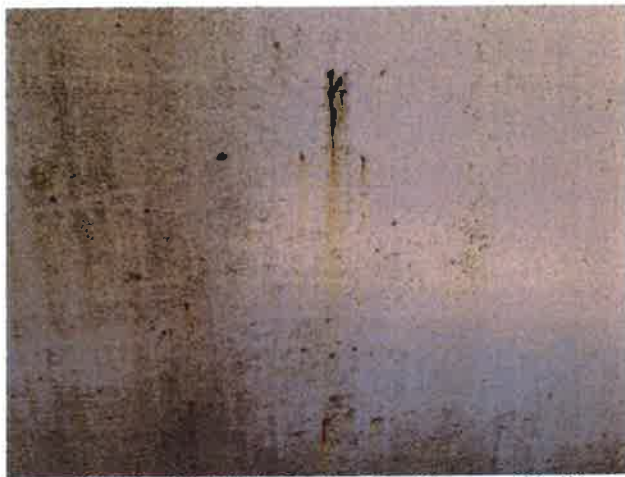
3 *Exterior Wall With Coating Loss/Damage, Chalking Exposed Underlying Steel, Mild Surface Corrosion, Mildew And Corrosion Staining*

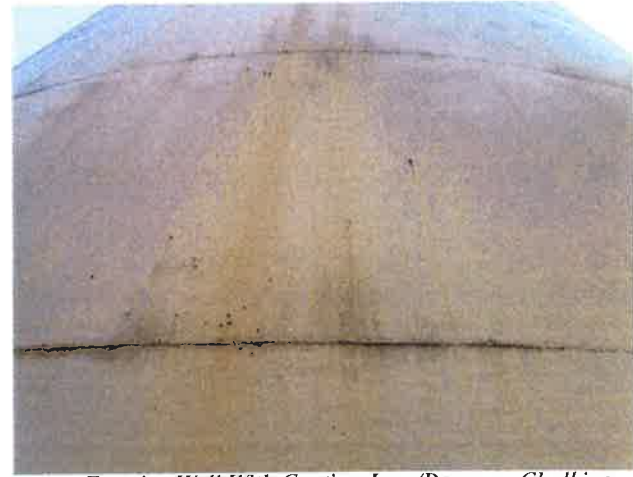
4 *Exterior Wall With Coating Loss/Damage, Chalking Exposed Underlying Steel, Mild Surface Corrosion, Mildew And Corrosion Staining*

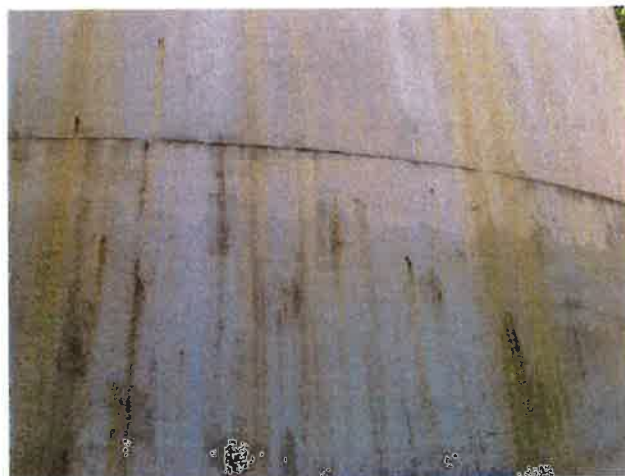
5 *Exterior Wall With Coating Loss/Damage, Chalking Exposed Underlying Steel, Mild Surface Corrosion, Mildew And Corrosion Staining*

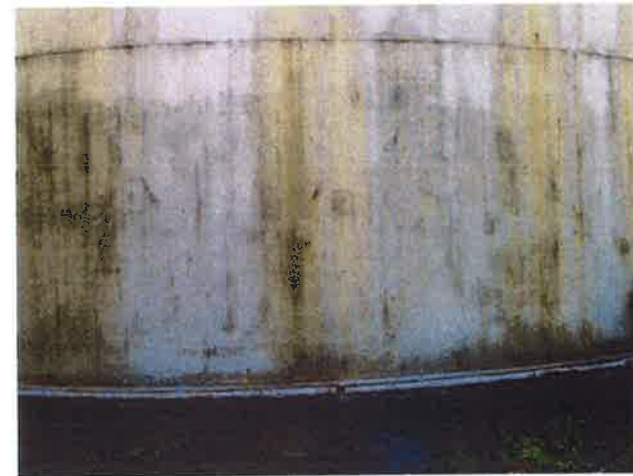
6 *Exterior Wall With Coating Loss/Damage, Chalking Exposed Underlying Steel, Mild Surface Corrosion, Mildew And Corrosion Staining*

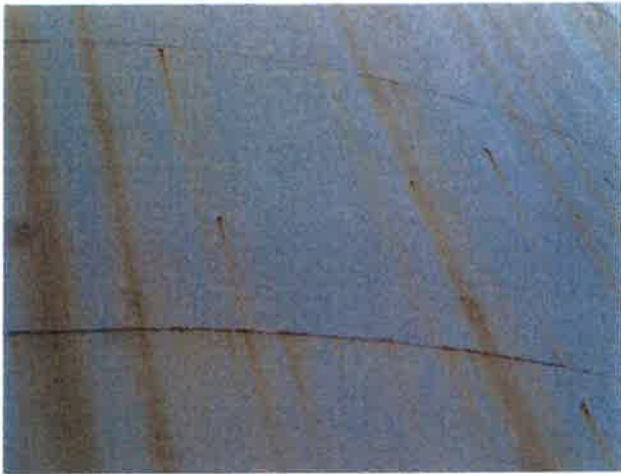
7 *Exterior Wall With Coating Loss/Damage, Chalking Exposed Underlying Steel, Mild Surface Corrosion, Mildew And Corrosion Staining*

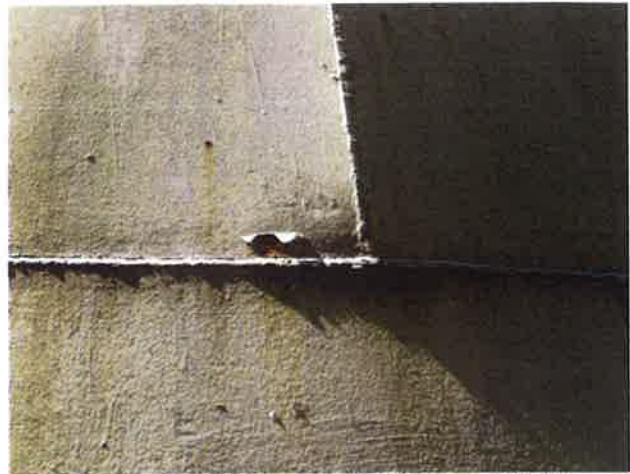
8 *Exterior Wall With Coating Loss/Damage, Chalking Exposed Underlying Steel, Mild Surface Corrosion, Mildew And Corrosion Staining*

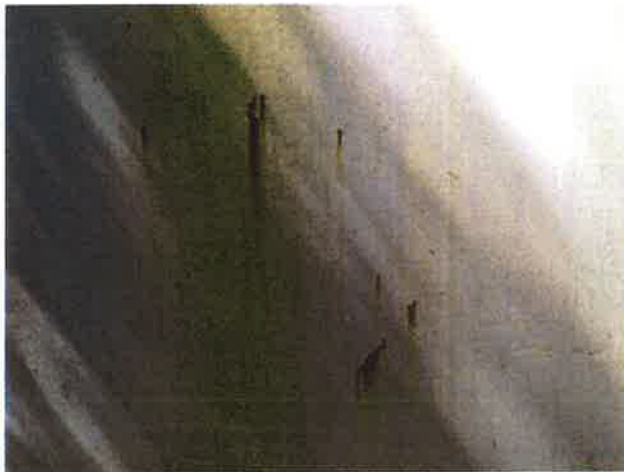
9 *Exterior Wall With Coating Loss/Damage, Chalking Exposed Underlying Steel, Mild Surface Corrosion, Mildew And Corrosion Staining*

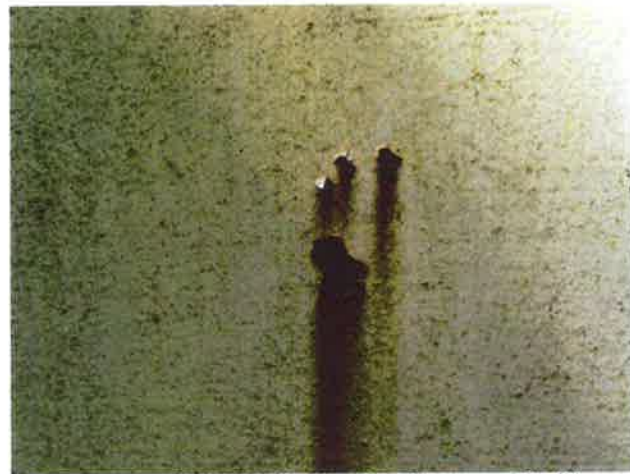
10 *Exterior Wall With Coating Loss/Damage, Chalking Exposed Underlying Steel, Mild Surface Corrosion, Mildew And Corrosion Staining*

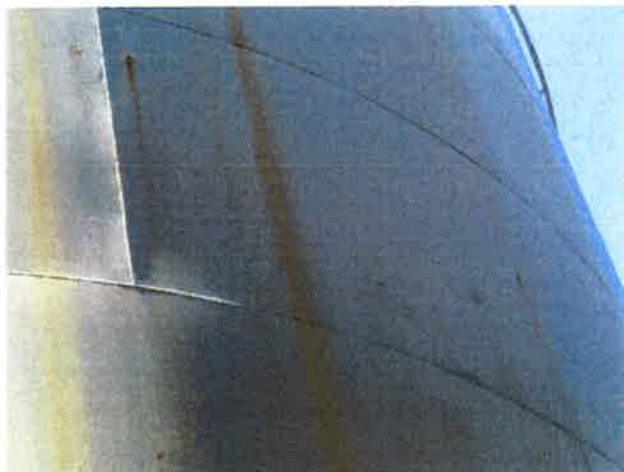
11 *Exterior Wall With Coating Loss/Damage, Chalking Exposed Underlying Steel, Mild Surface Corrosion, Mildew And Corrosion Staining*

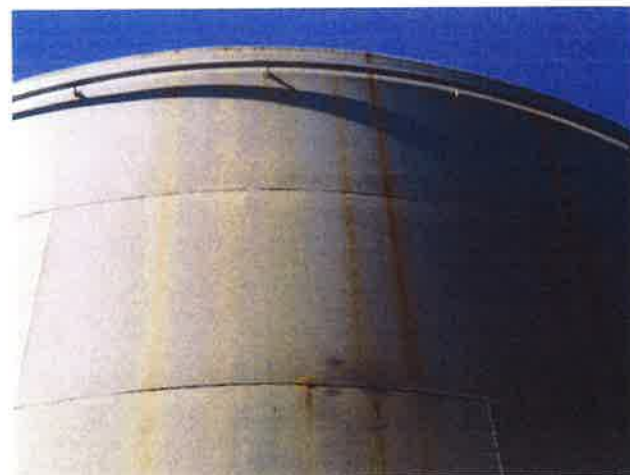
12 *Exterior Wall With Coating Loss/Damage, Chalking Exposed Underlying Steel, Mild Surface Corrosion, Mildew And Corrosion Staining*

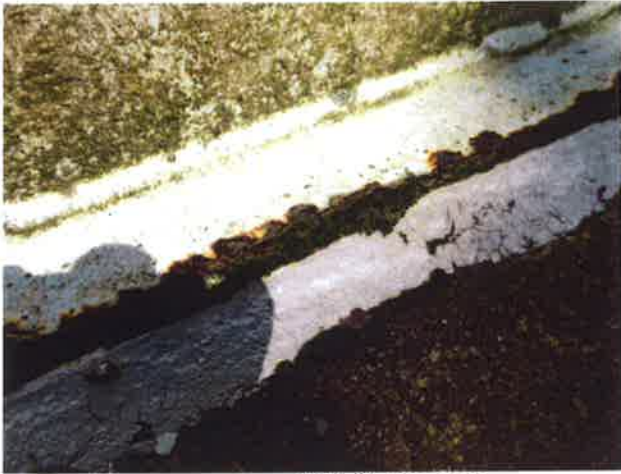
13 *Steel Floor Extension With Coating Loss, Exposed Steel, Mild To Moderate Surface Corrosion And Mildew*

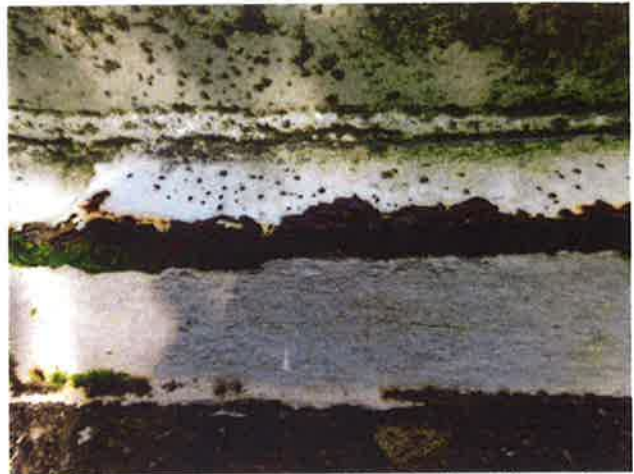
14 *Steel Floor Extension With Coating Loss, Exposed Steel, Mild To Moderate Surface Corrosion And Mildew*

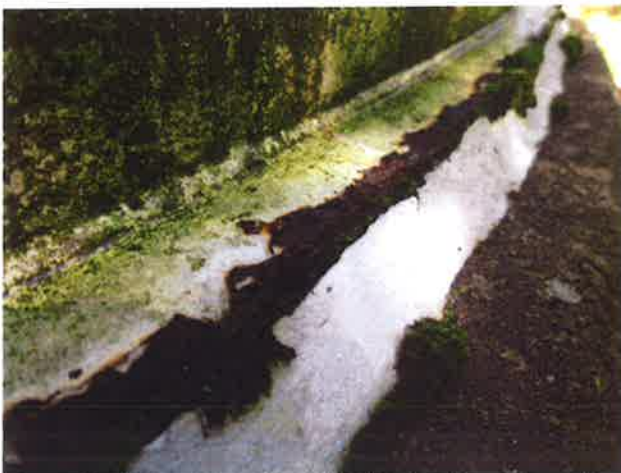
15 *Steel Floor Extension With Coating Loss, Exposed Steel, Mild To Moderate Surface Corrosion And Mildew*

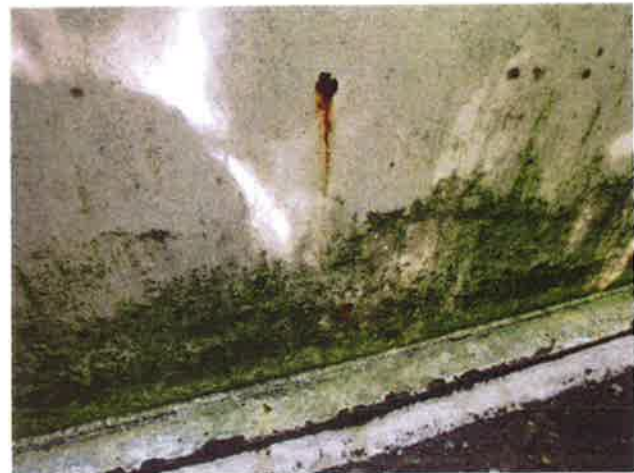
16 *Steel Floor Extension With Coating Loss, Exposed Steel, Mild To Moderate Surface Corrosion And Mildew*

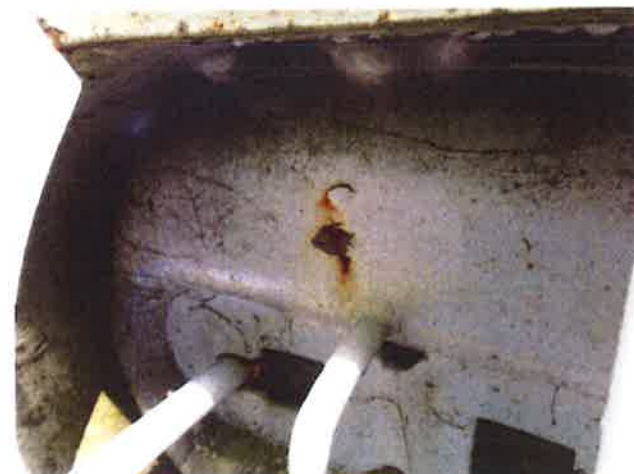
18 *Manway Lid With Coating Loss, Exposed Steel And Mild Surface Corrosion*

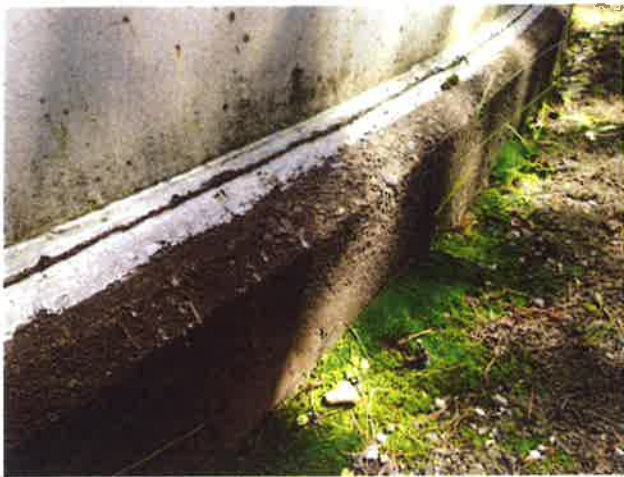
19 *Concrete Foundation*

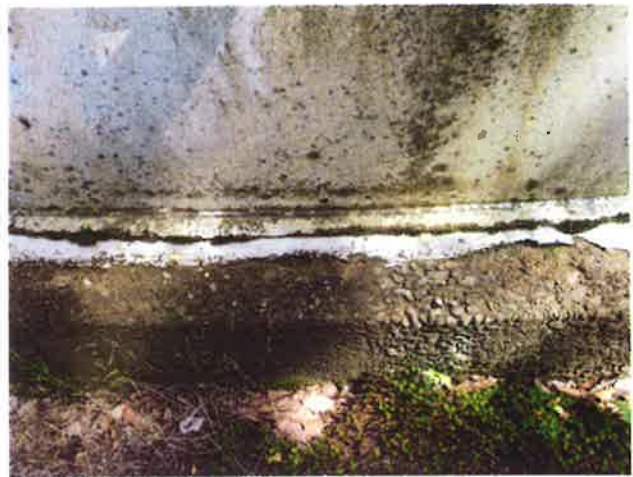
20 *Concrete Foundation*

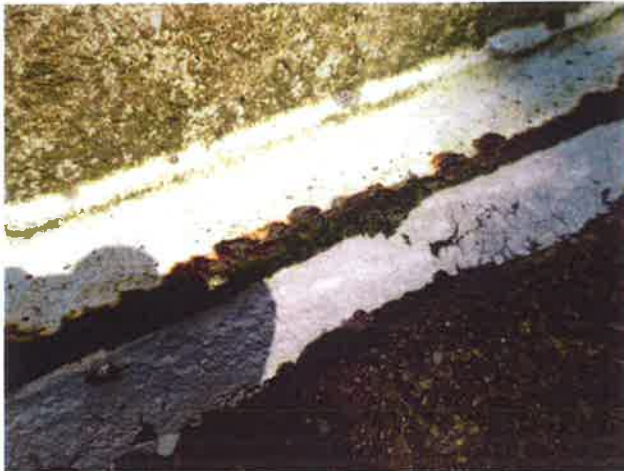
21 *Concrete Foundation - Tank Base To Wall Junction
With Sealant Degrading Due To Weathering*

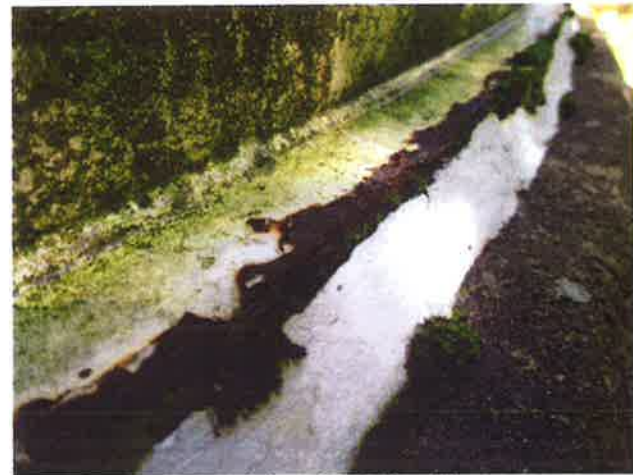
22 *Concrete Foundation - Tank Base To Wall Junction
With Sealant Degrading Due To Weathering*

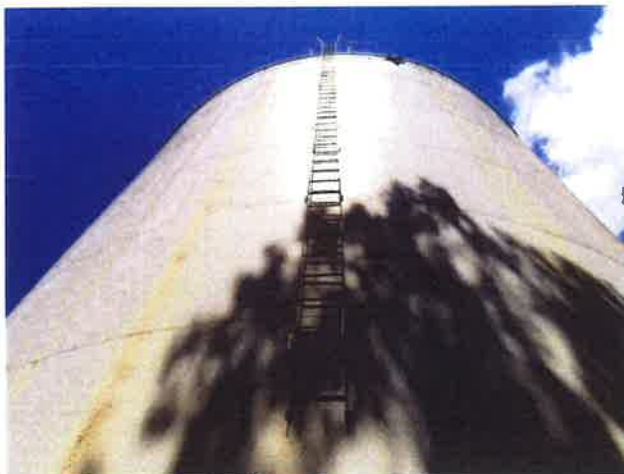
23 *Roof Access Ladder*

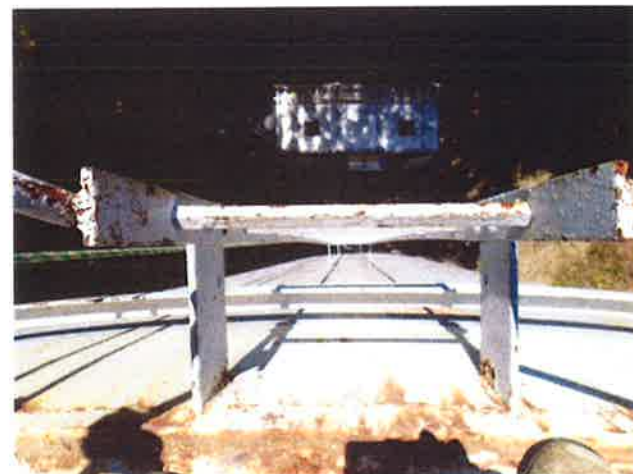
24 *Roof Access Ladder With Coating Lifting/Peeling,
Exposed Primary Coating, Exposed Underlying
Steel And Mild Surface Corrosion*

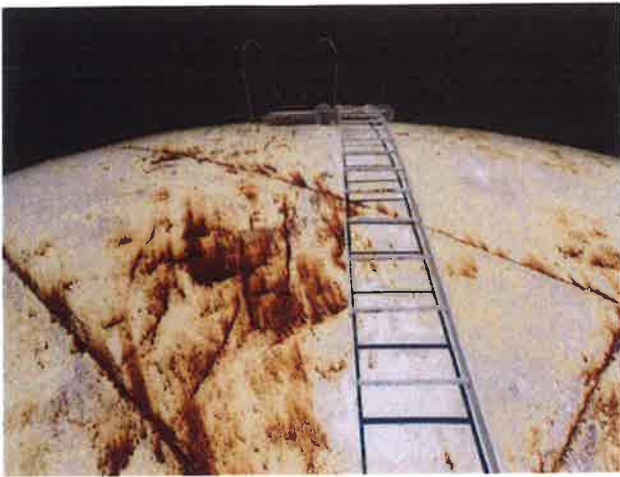
25 *Vent Access Ladder With Coating Lifting/Peeling, Exposed Primary Coating, Exposed Underlying Steel And Mild Surface Corrosion*

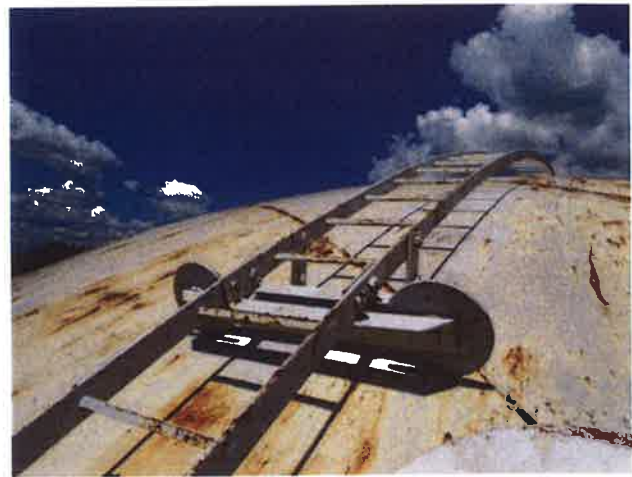
26 *Vent Access Ladder With Coating Lifting/Peeling, Exposed Primary Coating, Exposed Underlying Steel And Mild Surface Corrosion*

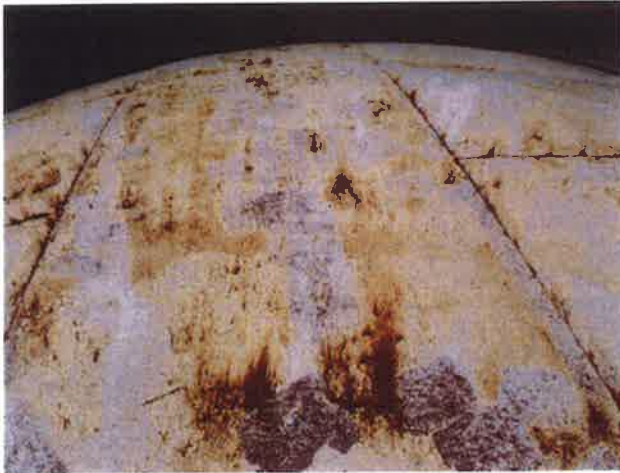
27 *Roof With Coating Nearing Expiration, Exposed Primary Coating, Exposed Underlying Steel, Mild Surface Corrosion And Corrosion Staining*

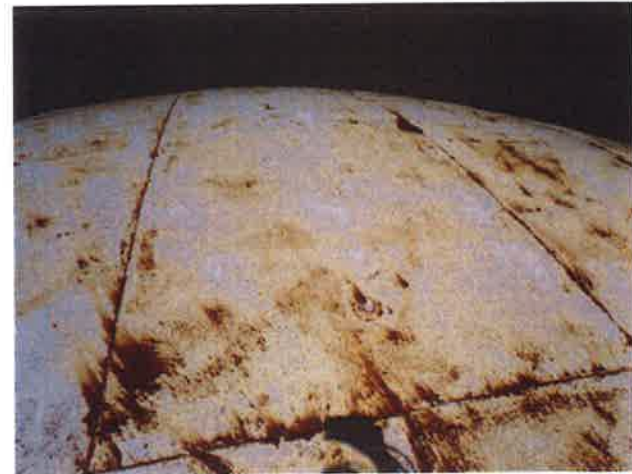
28 *Roof With Coating Nearing Expiration, Exposed Primary Coating, Exposed Underlying Steel, Mild Surface Corrosion And Corrosion Staining*

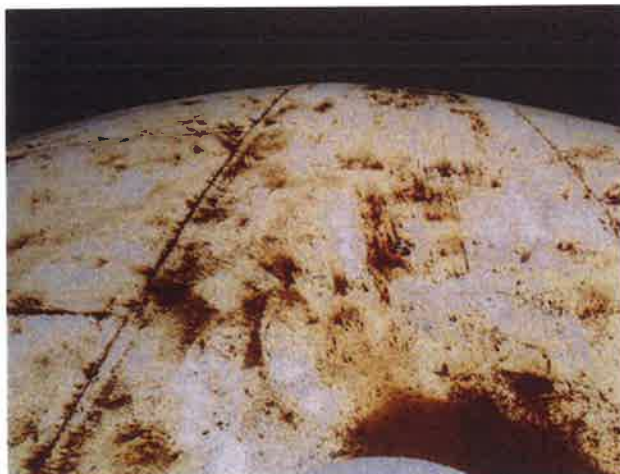
29 *Roof With Coating Nearing Expiration, Exposed Primary Coating, Exposed Underlying Steel, Mild Surface Corrosion And Corrosion Staining*

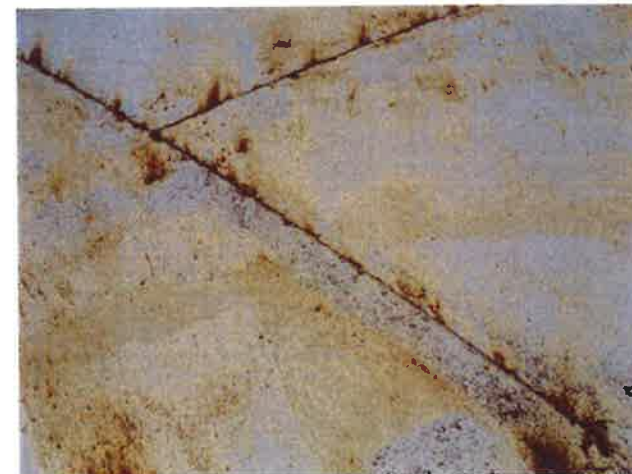
30 *Roof With Coating Nearing Expiration, Exposed Primary Coating, Exposed Underlying Steel, Mild Surface Corrosion And Corrosion Staining*

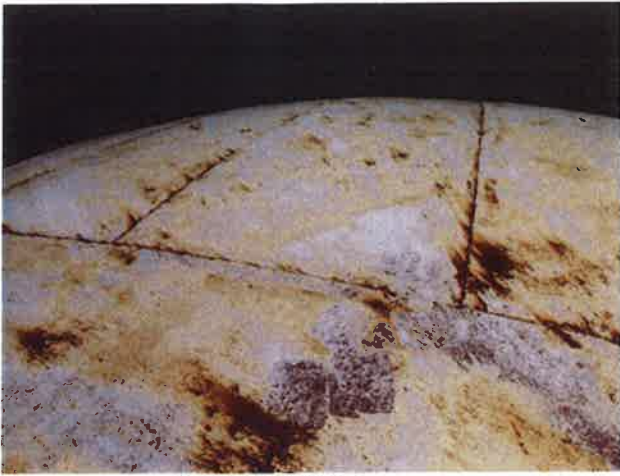
31 *Roof With Coating Nearing Expiration, Exposed Primary Coating, Exposed Underlying Steel, Mild Surface Corrosion And Corrosion Staining*

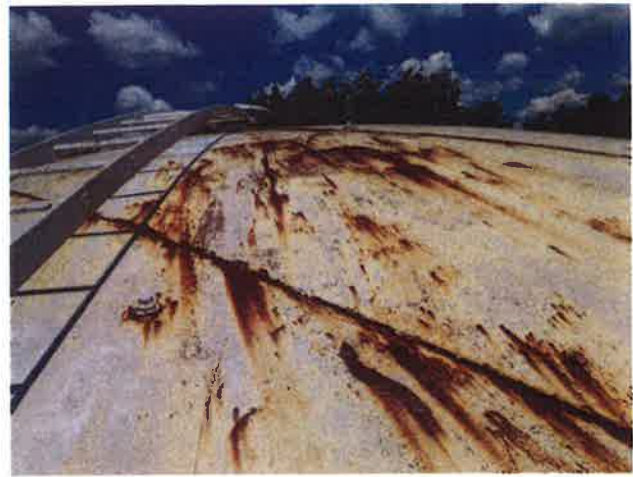
32 *Roof With Coating Nearing Expiration, Exposed Primary Coating, Exposed Underlying Steel, Mild Surface Corrosion And Corrosion Staining*

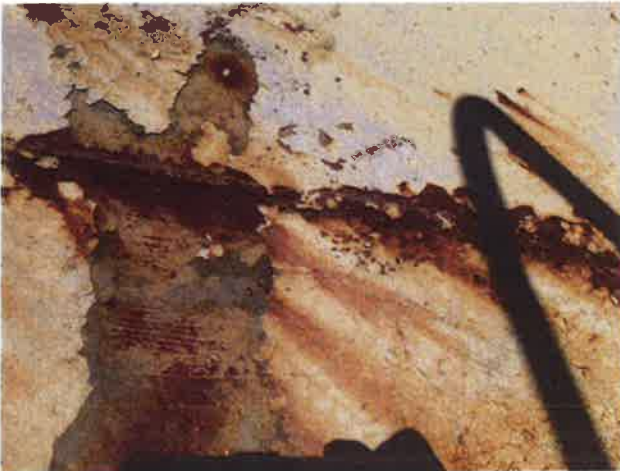
33 *Roof With Coating Nearing Expiration, Exposed Primary Coating, Exposed Underlying Steel, Mild Surface Corrosion And Corrosion Staining*

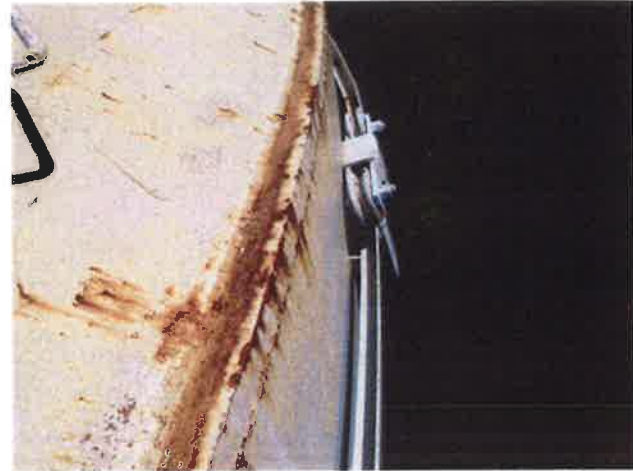
34 *Roof With Coating Nearing Expiration, Exposed Primary Coating, Exposed Underlying Steel, Mild Surface Corrosion And Corrosion Staining*

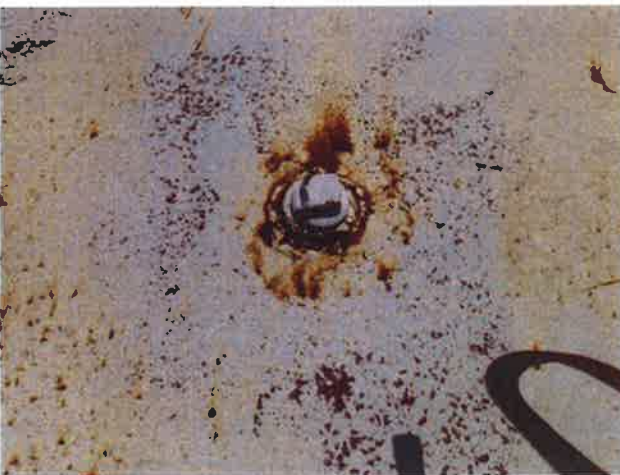
35 *Secure Roof Dome Rigging Hole*

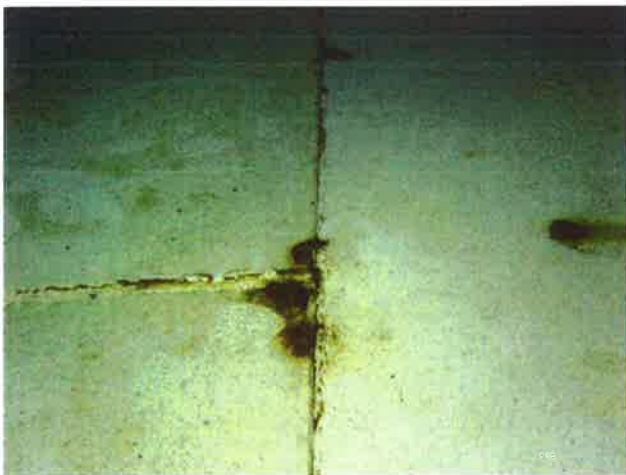
47 *Floor With Ruptured Coating Blisters, Exposed Underlying Steel, Mild Surface Corrosion And Mild Staining*

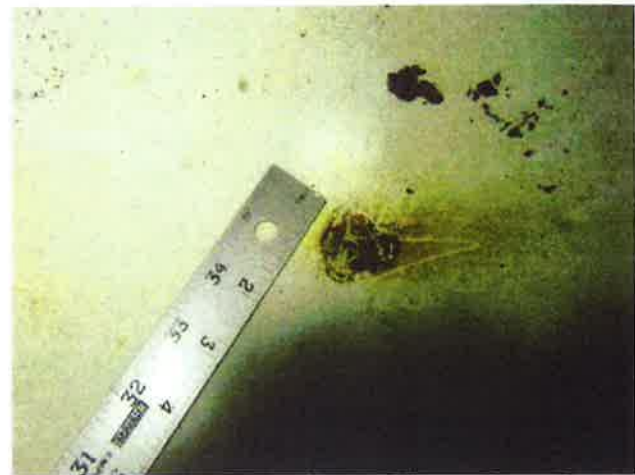
48 *Floor With Ruptured Coating Blisters, Exposed Underlying Steel, Mild Surface Corrosion And Mild Staining*

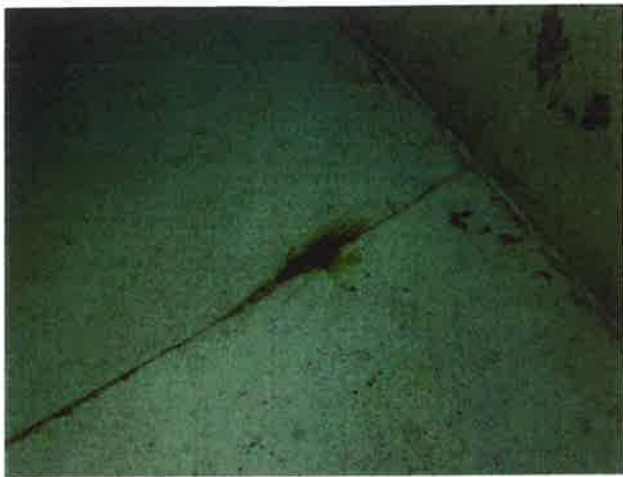
49 *Floor With Ruptured Coating Blisters, Exposed Underlying Steel, Mild Surface Corrosion And Mild Staining*

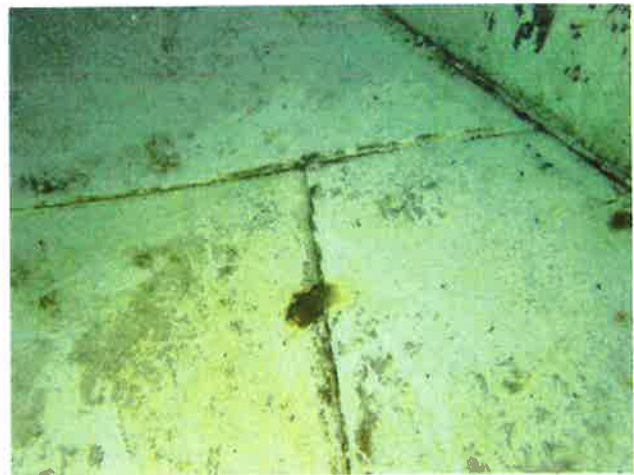
50 *Floor With Ruptured Coating Blisters, Exposed Underlying Steel, Mild Surface Corrosion And Mild Staining*

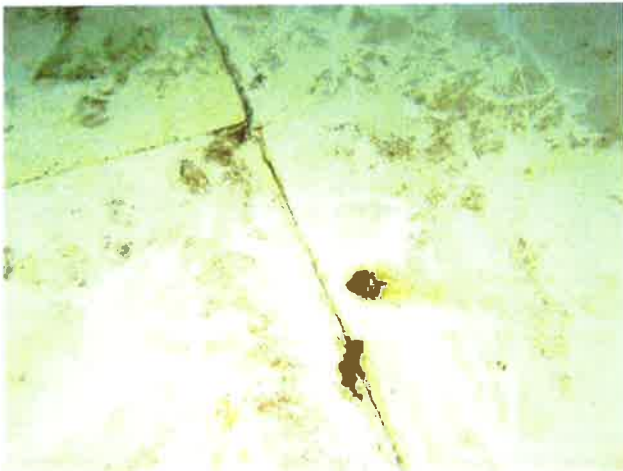
51 *Floor With Ruptured Coating Blisters, Exposed Underlying Steel, Mild Surface Corrosion And Mild Staining*

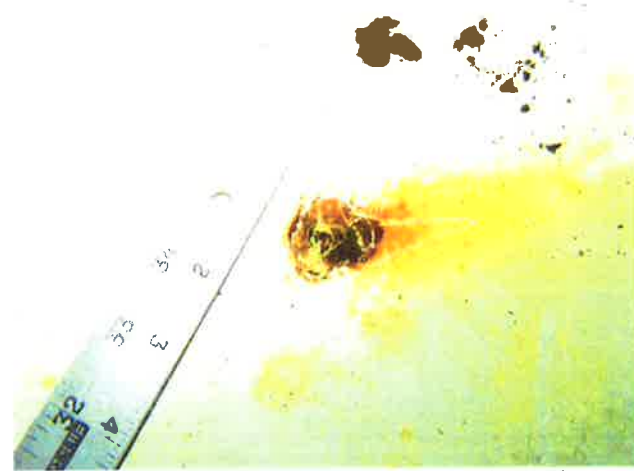
52 *Floor With Ruptured Coating Blisters, Exposed Underlying Steel, Mild Surface Corrosion And Mild Staining*

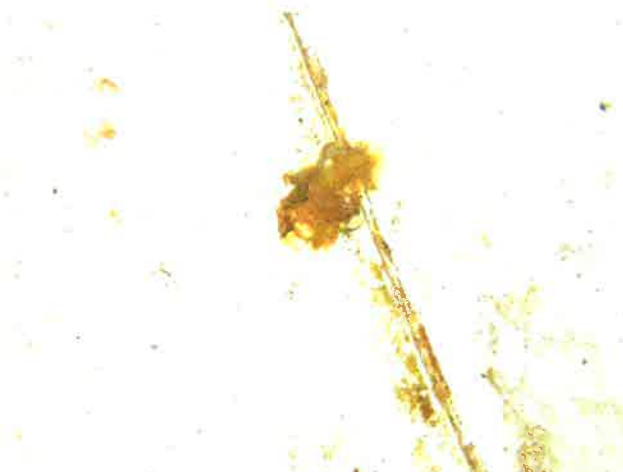
53 *Floor With Ruptured Coating Blisters, Exposed Underlying Steel, Mild Surface Corrosion And Mild Staining*

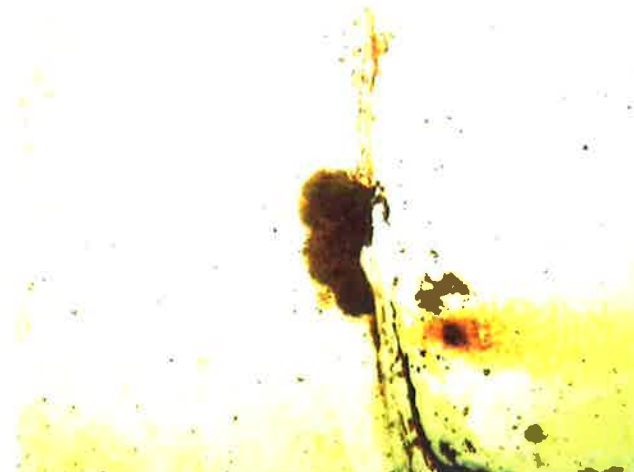
54 *Floor With Ruptured Coating Blisters, Exposed Underlying Steel, Mild Surface Corrosion And Mild Staining*

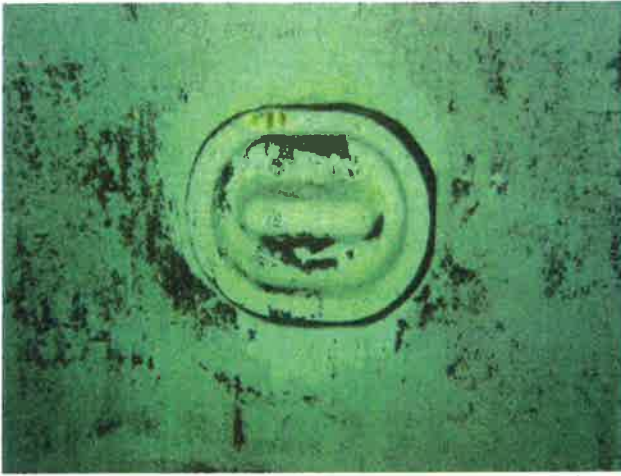
55 *Manway With Ruptured Coating Blisters, Exposed Underlying Steel And Mild Surface Corrosion*

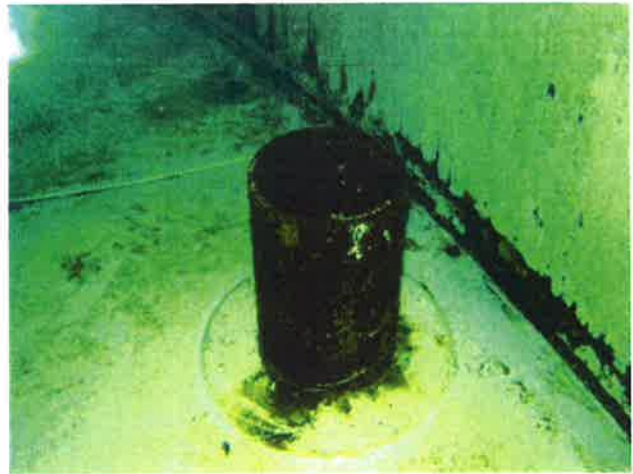
56 *Influent/Effluent Pipe*

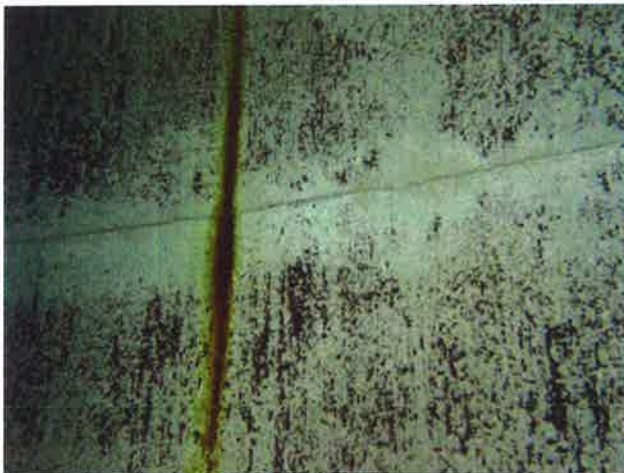
57 *Interior Wall With Coating Loss, Exposed Steel, Surface Corrosion And Moderate To Heavy Staining*

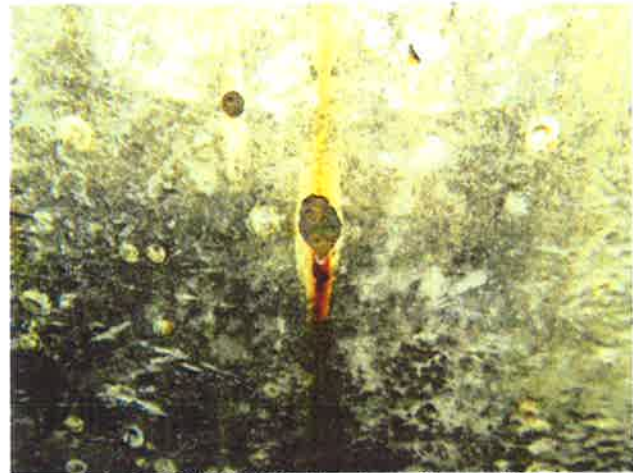
58 *Interior Wall With Coating Loss, Exposed Steel, Surface Corrosion And Moderate To Heavy Staining*

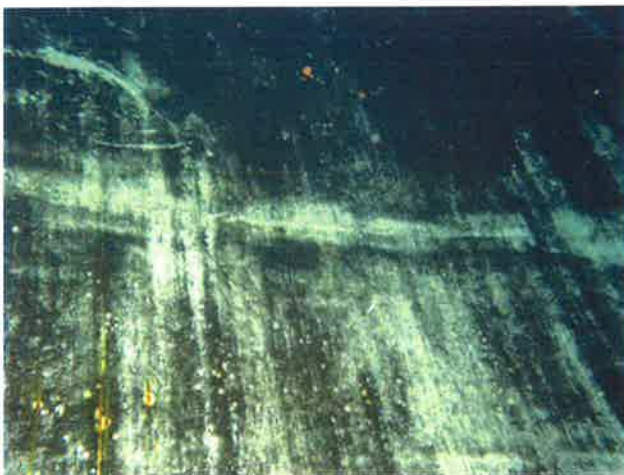
59 *Interior Wall With Coating Loss, Exposed Steel, Surface Corrosion And Moderate To Heavy Staining*

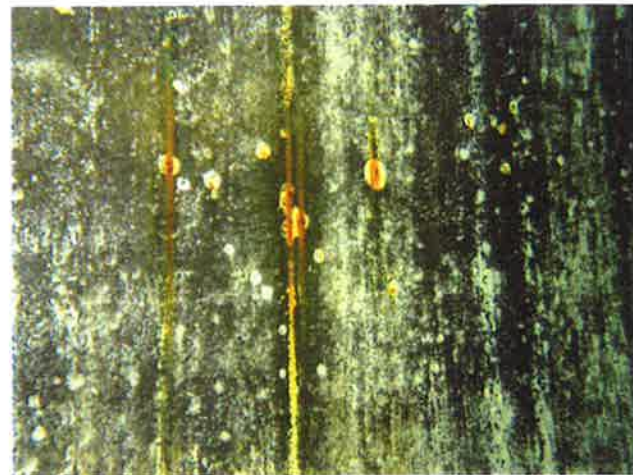
60 *Interior Wall With Coating Loss, Exposed Steel, Surface Corrosion And Moderate To Heavy Staining*

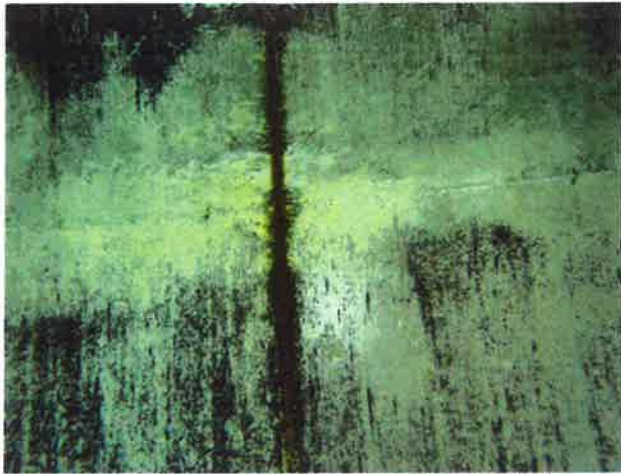
61 *Interior Wall With Coating Loss, Exposed Steel, Surface Corrosion And Moderate To Heavy Staining*

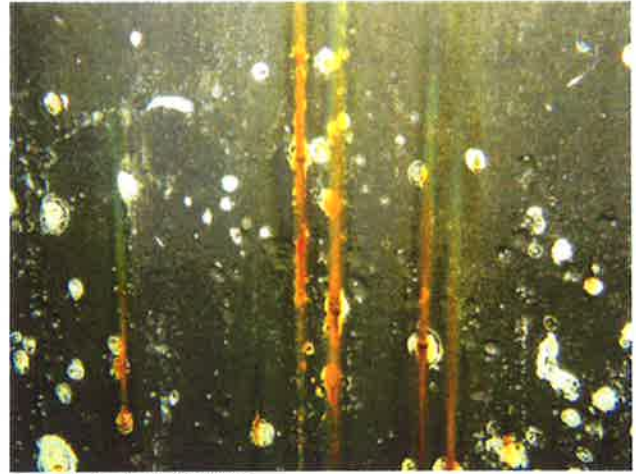
62 *Interior Wall With Coating Loss, Exposed Steel, Surface Corrosion And Moderate To Heavy Staining*

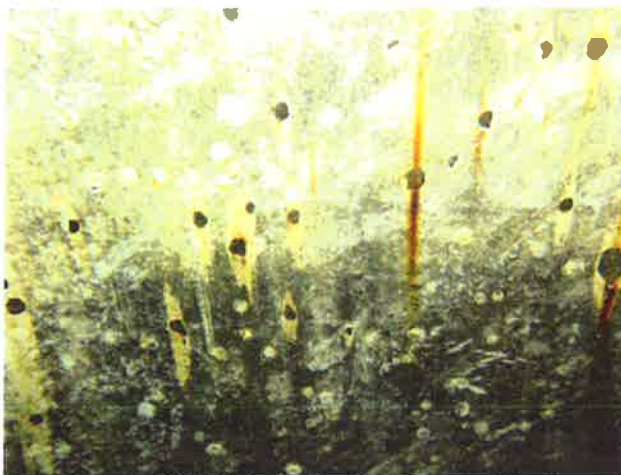
63 *Interior Wall With Coating Loss, Exposed Steel, Surface Corrosion And Moderate To Heavy Staining*

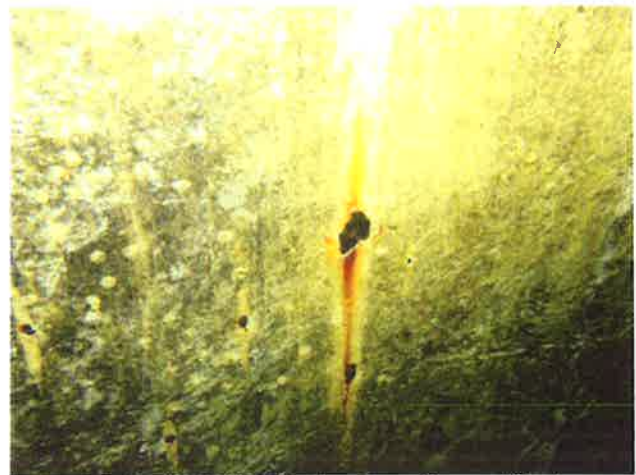
64 *Interior Wall With Coating Loss, Exposed Steel, Surface Corrosion And Moderate To Heavy Staining*

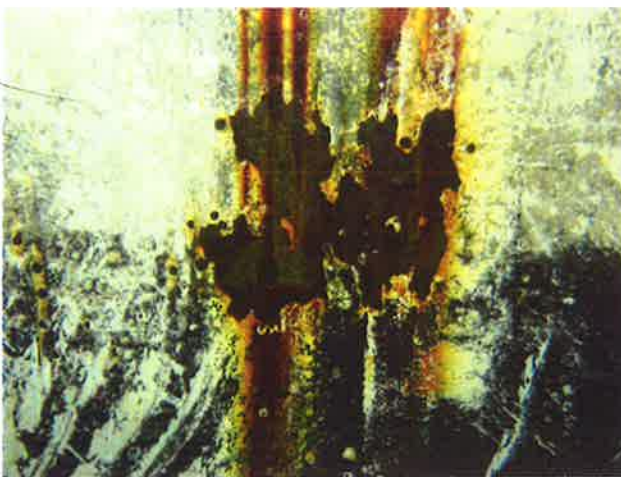
65 *Interior Wall With Coating Loss, Exposed Steel, Surface Corrosion And Moderate To Heavy Staining*

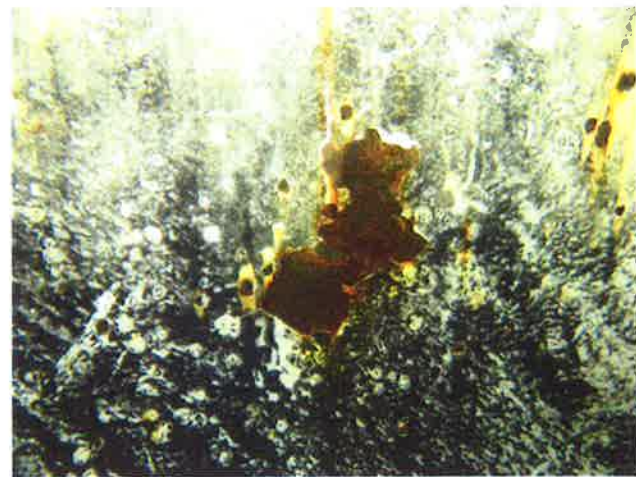
66 *Interior Wall With Coating Loss, Exposed Steel, Surface Corrosion And Moderate To Heavy Staining*

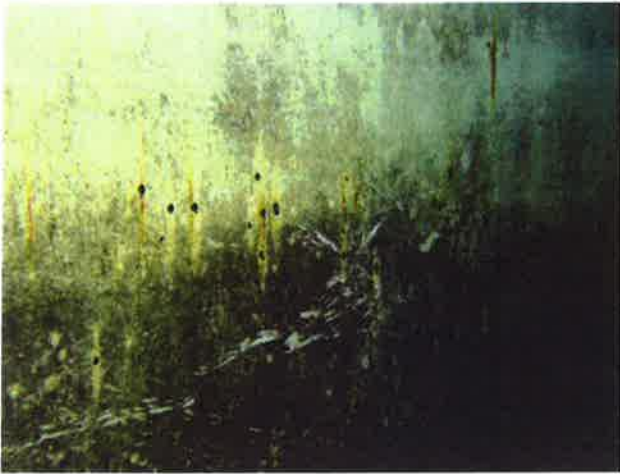
67 Interior Wall With Coating Loss, Exposed Steel, Surface Corrosion And Moderate To Heavy Staining

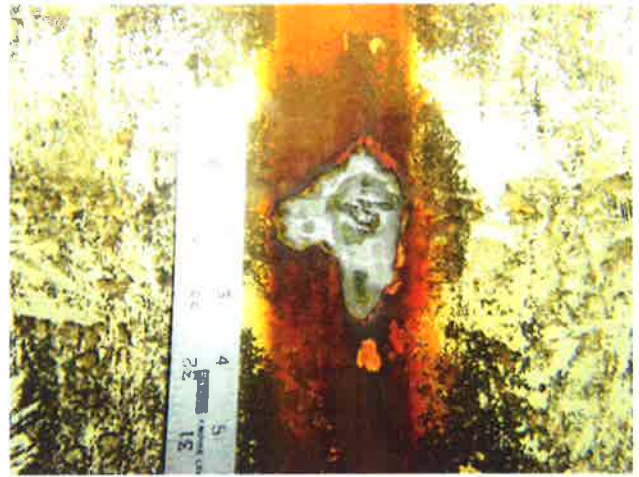
68 Interior Wall Welds With Coating Loss, Steel Fatigue (Pitting) And Moderate To Heavy Staining

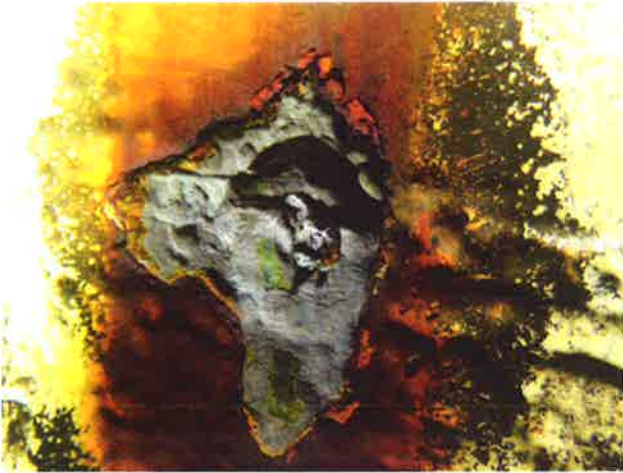
69 Interior Wall Welds With Coating Loss, Steel Fatigue (Pitting) And Moderate To Heavy Staining

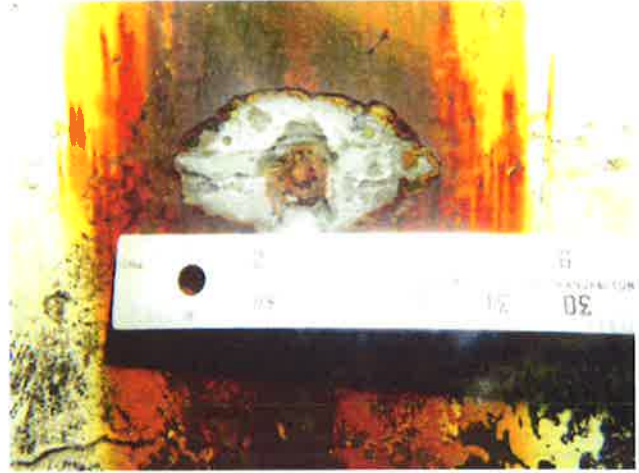
70 Interior Wall Welds With Coating Loss, Steel Fatigue (Pitting) And Moderate To Heavy Staining

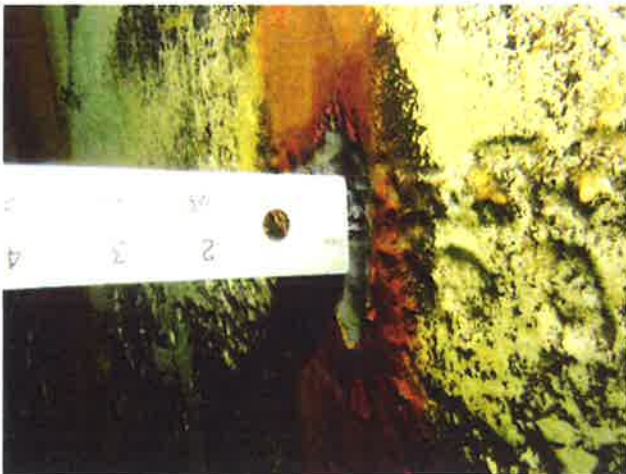
71 Interior Wall Welds With Coating Loss, Steel Fatigue (Pitting) And Moderate To Heavy Staining
