January 31, 2020

100 International Drive, Suite 152, Portsmouth, NH 03801
Tel: 603.431.3937

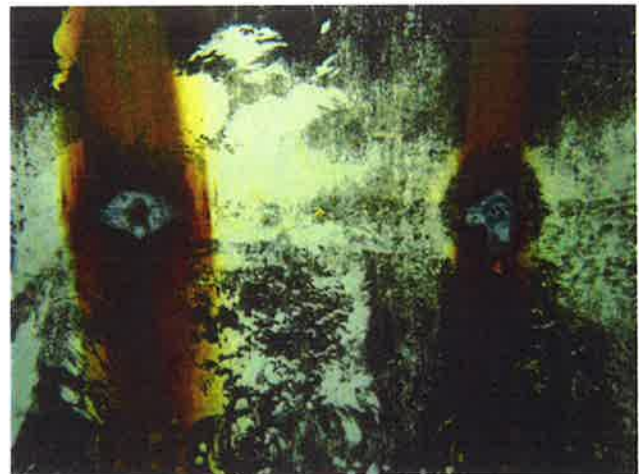
72 Interior Wall Welds With Coating Loss, Steel Fatigue (Pitting) And Moderate To Heavy Staining

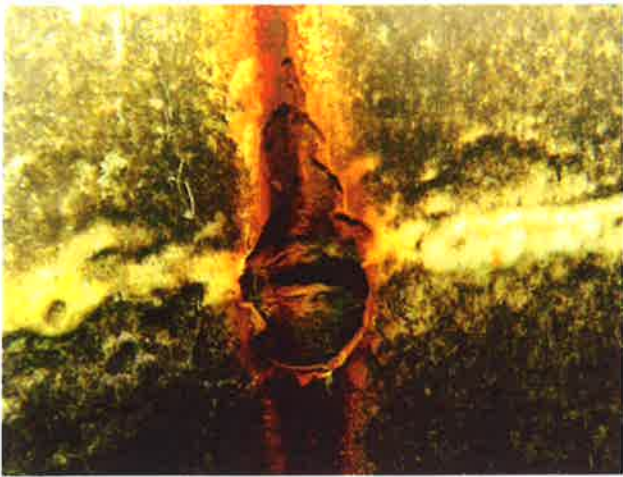
73 *Interior Wall Welds With Coating Loss, Steel Fatigue (Pitting) And Moderate To Heavy Staining*

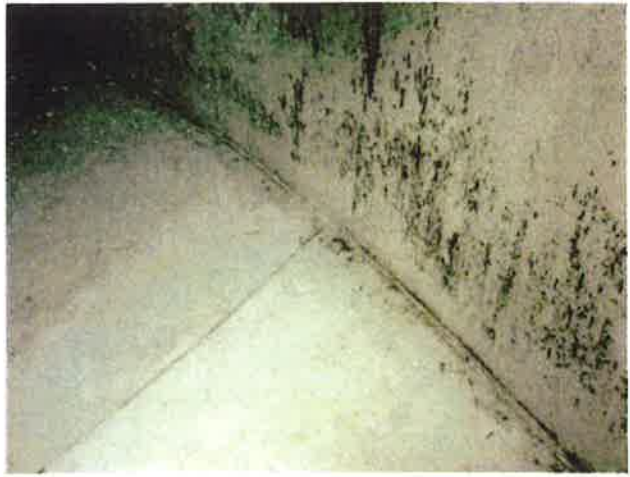
74 *Interior Wall With Moderate To Heavy Staining*

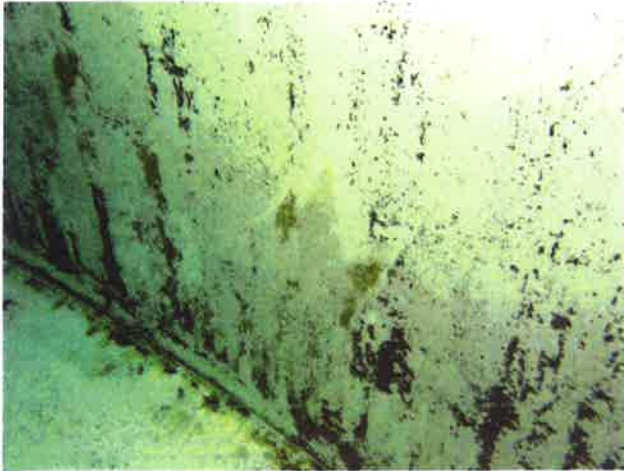
75 *Interior Wall With Moderate To Heavy Staining*

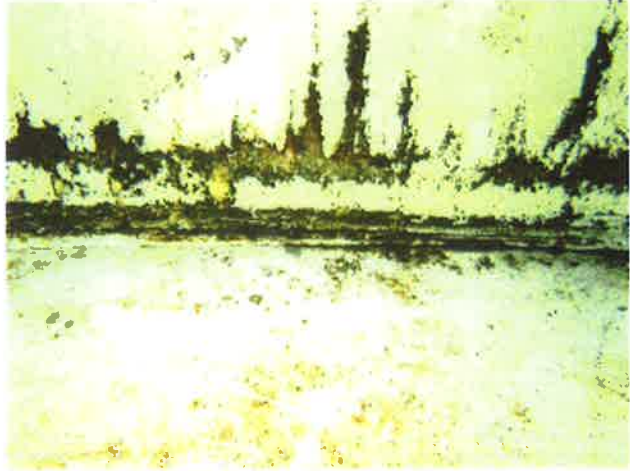
76 *Interior Wall With Moderate To Heavy Staining*

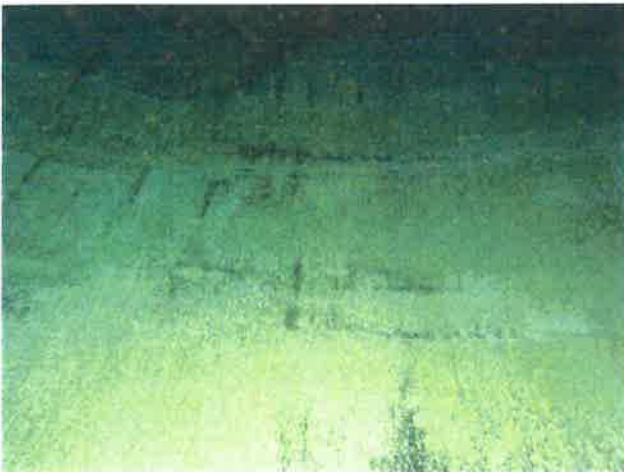
77 *Interior Wall With Moderate To Heavy Staining*

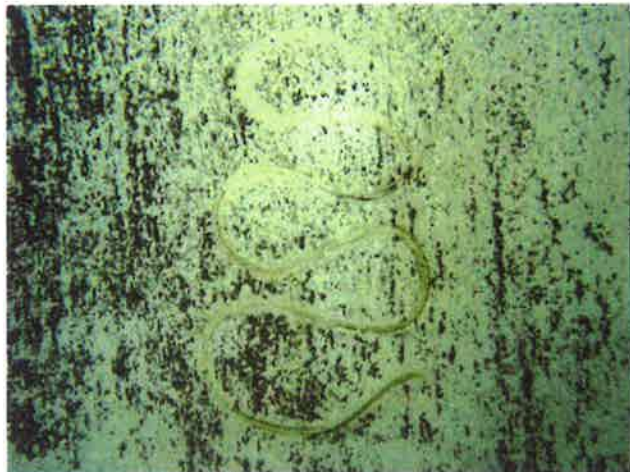
78 *Interior Wall With Moderate To Heavy Staining*

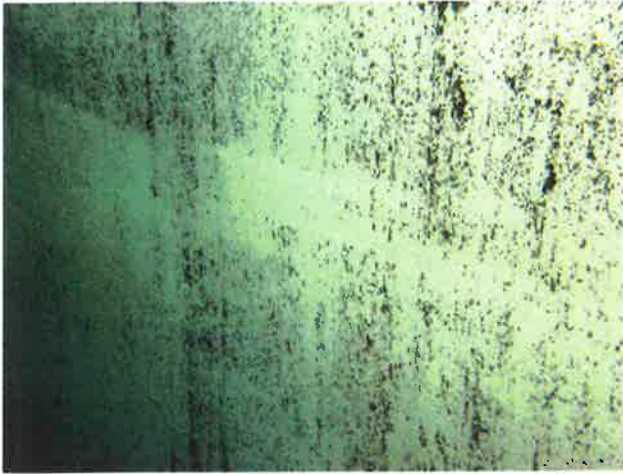
79 *Interior Wall With Moderate To Heavy Staining*

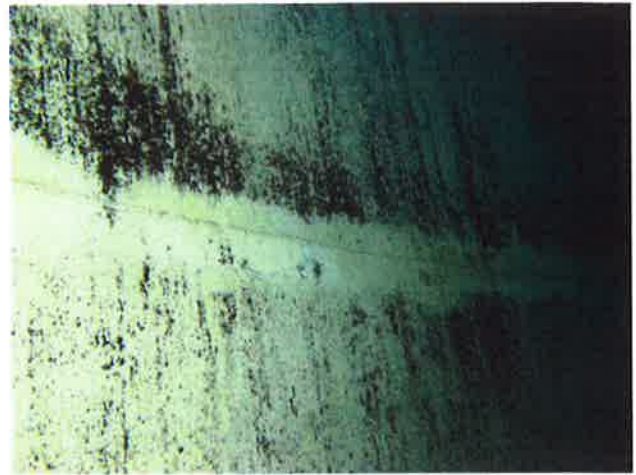
80 *Interior Wall With Moderate To Heavy Staining*

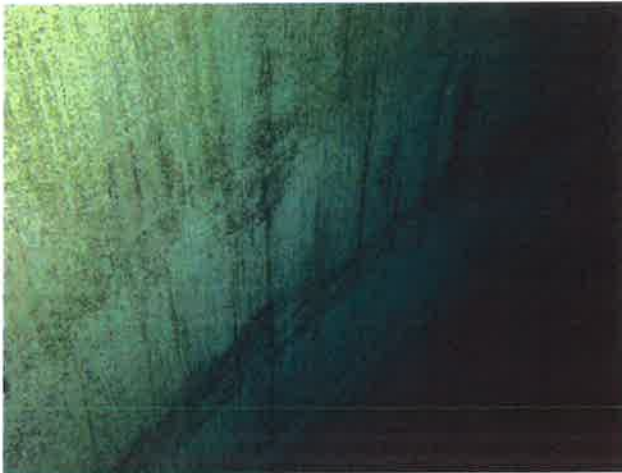
81 *Interior Wall With Moderate To Heavy Staining*

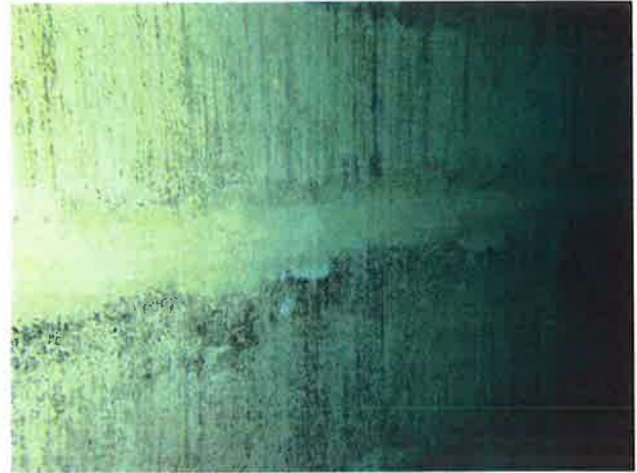
82 *Interior Wall With Moderate To Heavy Staining*

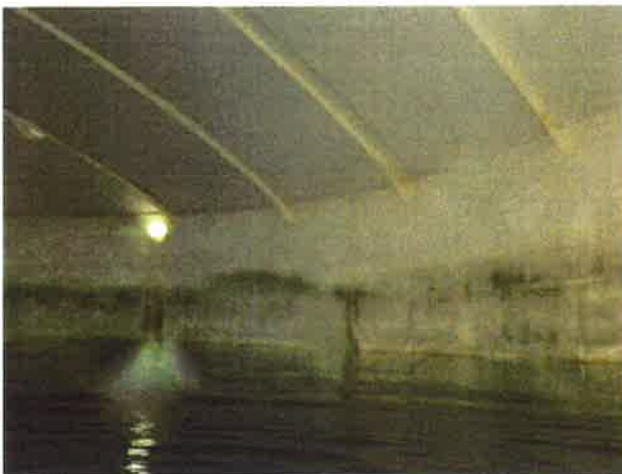
83 *Interior Wall With Moderate To Heavy Staining*

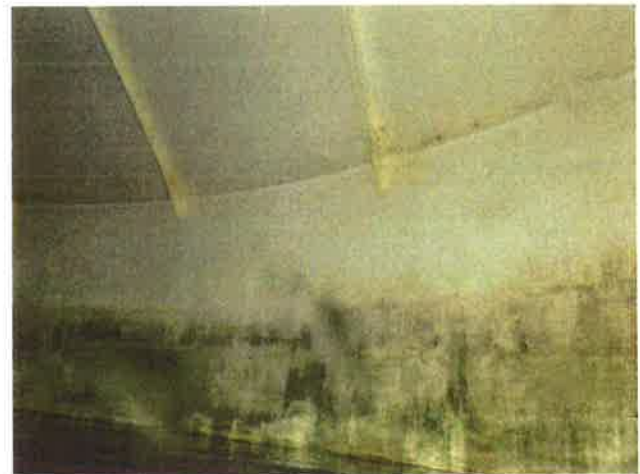
84 *Interior Wall With Moderate To Heavy Staining*

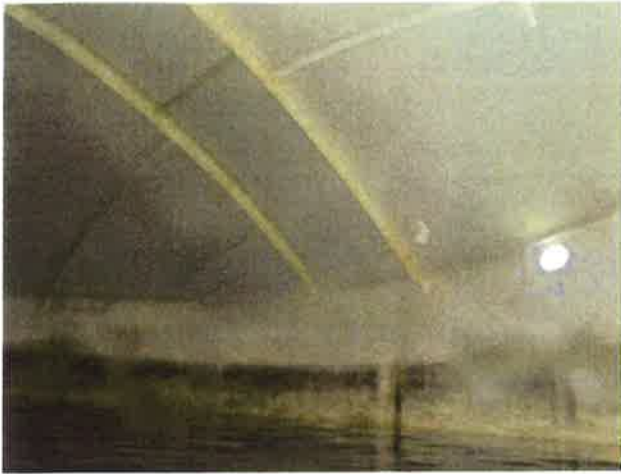
85 *Interior Wall With Moderate To Heavy Staining*

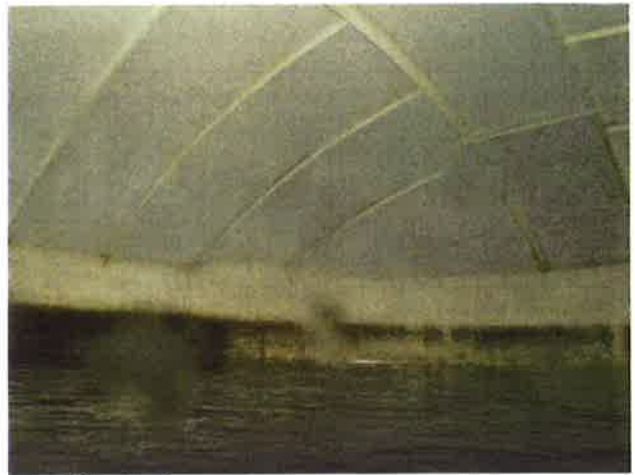
86 *Overhead With Mild Blotch Rusting*

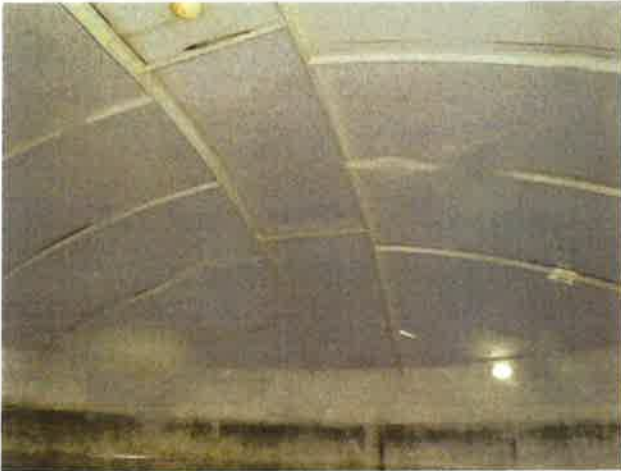
87 *Overhead With Mild Blotch Rusting*

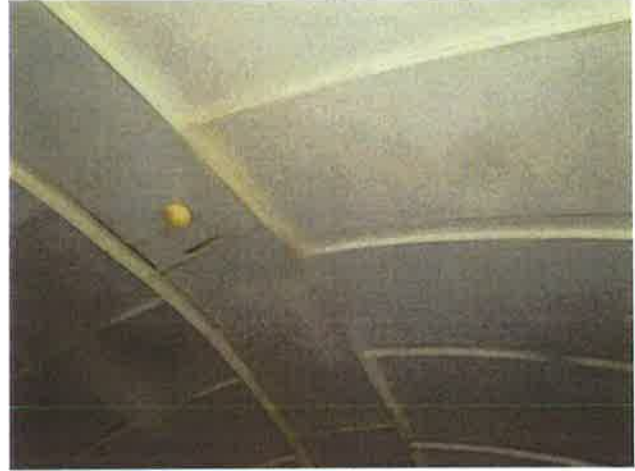
88 *Overhead With Mild Blotch Rusting*

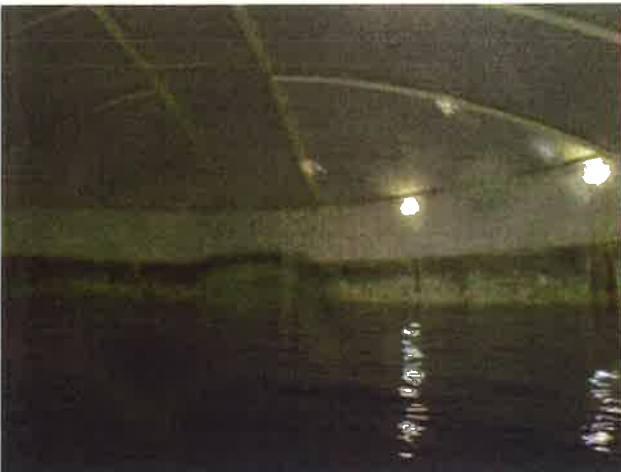
89 *Screened Overflow Cutouts*

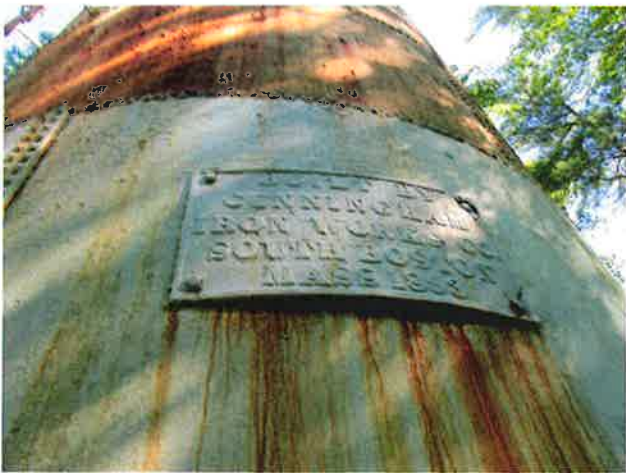
1 *Identification Plaque*

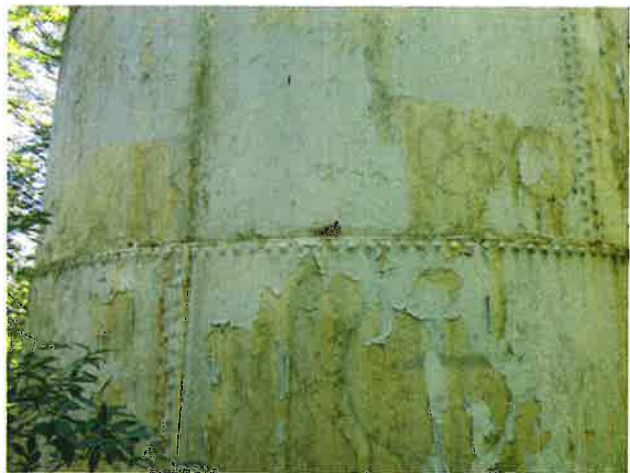
2 *Exterior Wall With Expired Coating/Peeling, Exposed Underlying Primary Coating, Rust Staining And Mildew*

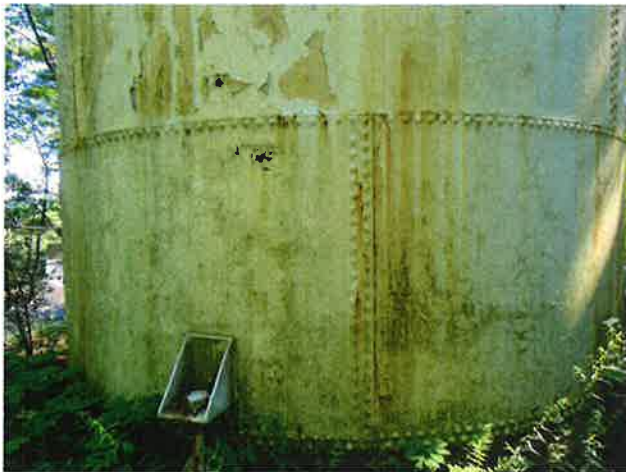
3 *Exterior Wall With Expired Coating/Peeling, Exposed Underlying Primary Coating, Rust Staining And Mildew*

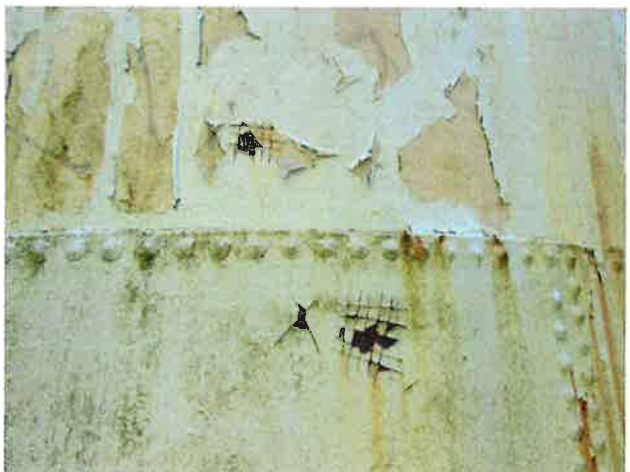
4 *Exterior Wall With Expired Coating/Peeling, Cross Hatch Adhesion Test Causing Exposed Underlying Steel, Surface Corrosion And Mildew*

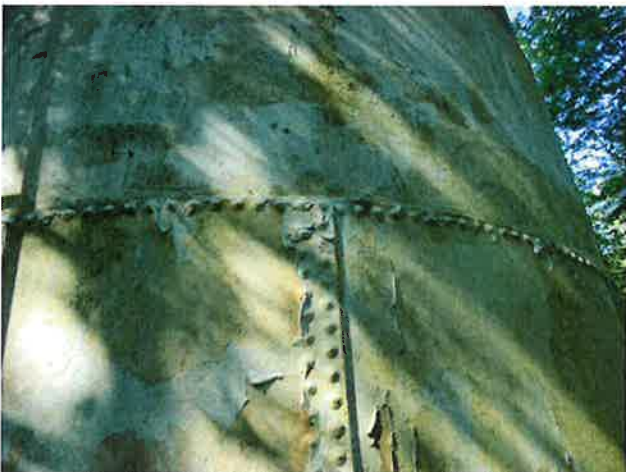
5 *Exterior Wall With Expired Coating/Peeling, Exposed Underlying Steel, Blotch Rusting, Mild To Moderate Surface Corrosion, Corrosive Staining, Rust Staining And Mildew*

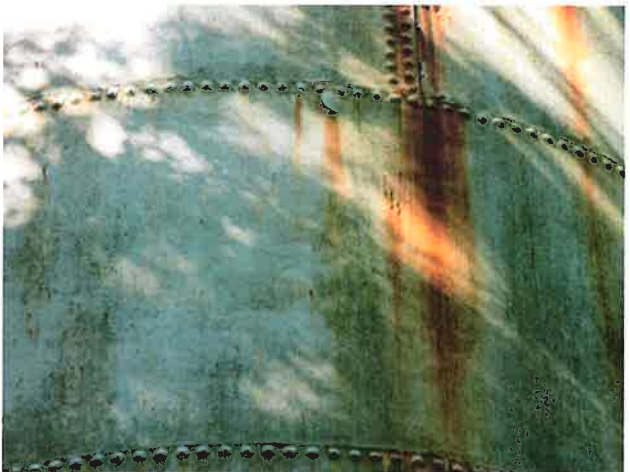
6 *Exterior Wall With Expired Coating/Peeling, Exposed Underlying Steel, Blotch Rusting, Mild To Moderate Surface Corrosion, Corrosive Staining, Rust Staining And Mildew*

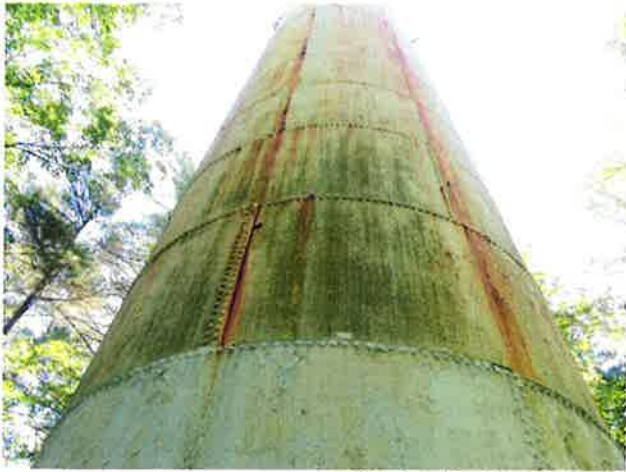
7 Exterior Wall With Expired Coating/Peeling, Exposed Underlying Steel, Blotch Rusting, Mild To Moderate Surface Corrosion, Corrosive Staining, Rust Staining And Mildew

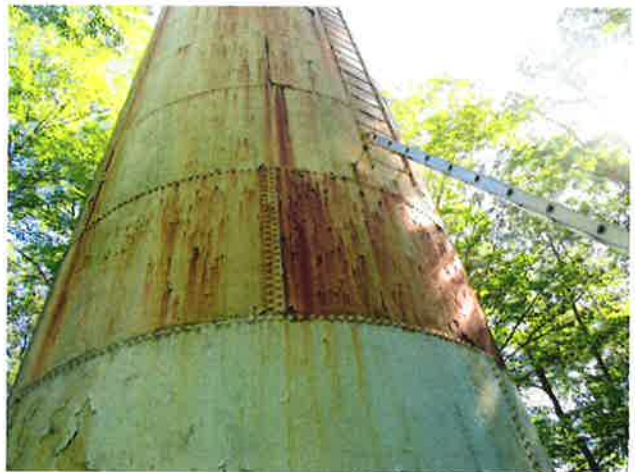
8 Exterior Wall With Expired Coating/Peeling, Exposed Underlying Steel, Blotch Rusting, Mild To Moderate Surface Corrosion, Corrosive Staining, Rust Staining And Mildew

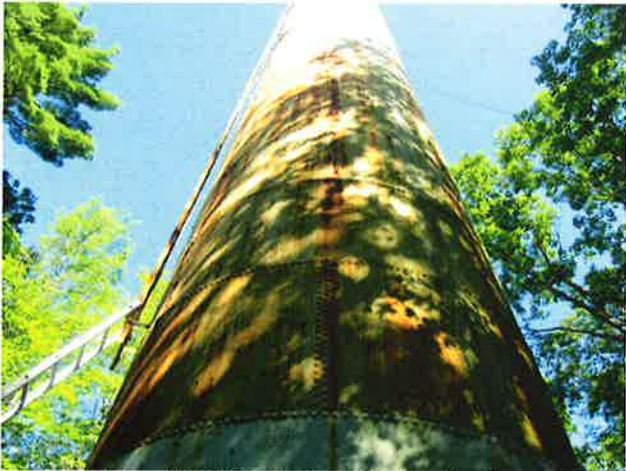
9 Exterior Wall With Expired Coating/Peeling, Exposed Underlying Steel, Blotch Rusting, Mild To Moderate Surface Corrosion, Corrosive Staining, Rust Staining And Mildew

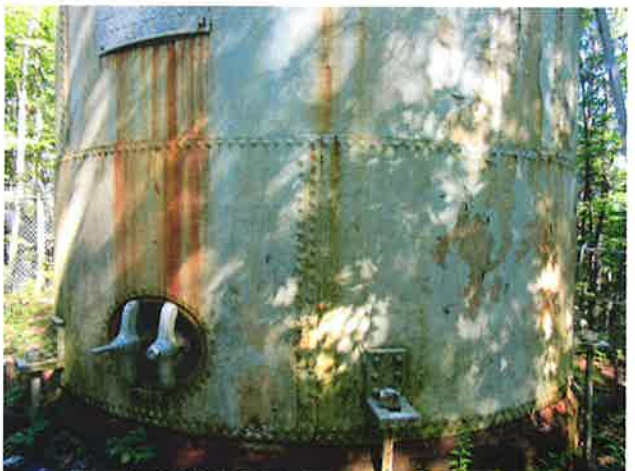
10 Exterior Wall With Expired Coating/Peeling, Exposed Underlying Steel, Blotch Rusting, Mild To Moderate Surface Corrosion, Corrosive Staining, Rust Staining And Mildew

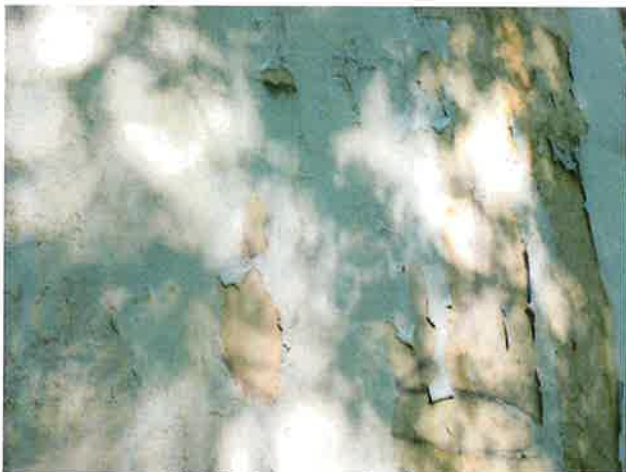
11 Exterior Wall With Expired Coating/Peeling, Exposed Underlying Steel, Blotch Rusting, Mild To Moderate Surface Corrosion, Corrosive Staining, Rust Staining And Mildew

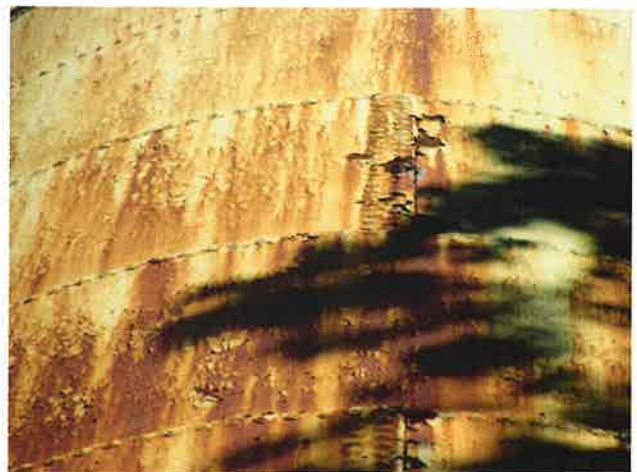
12 Exterior Wall With Expired Coating/Peeling, Exposed Underlying Steel, Blotch Rusting, Mild To Moderate Surface Corrosion, Corrosive Staining, Rust Staining And Mildew

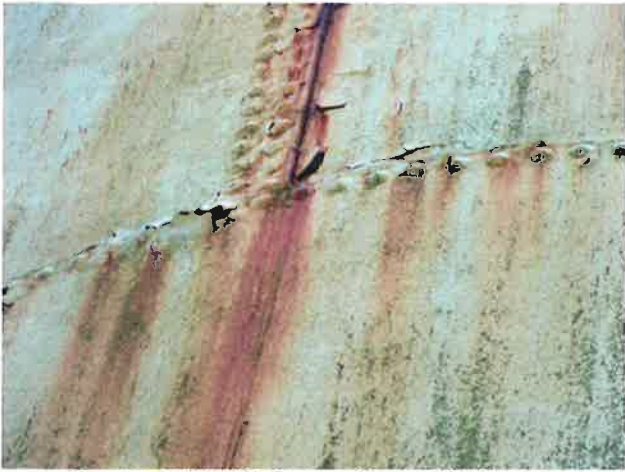
13 *Exterior Wall With Expired Coating/Peeling, Exposed Underlying Steel, Blotch Rusting, Mild To Moderate Surface Corrosion, Corrosive Staining, Rust Staining And Mildew*

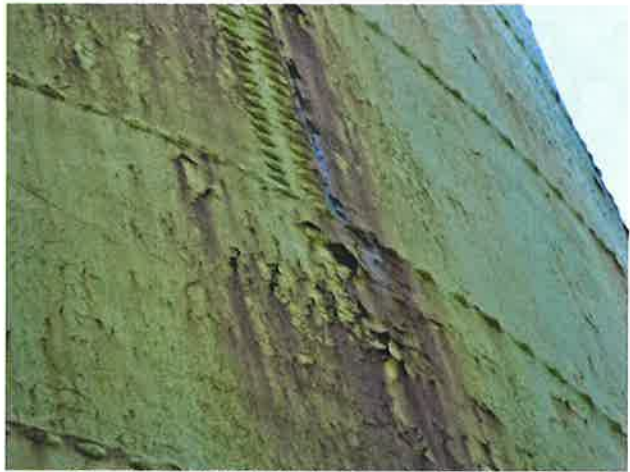
14 *Exterior Wall With Expired Coating/Peeling, Exposed Underlying Steel, Blotch Rusting, Mild To Moderate Surface Corrosion, Corrosive Staining, Rust Staining And Mildew*

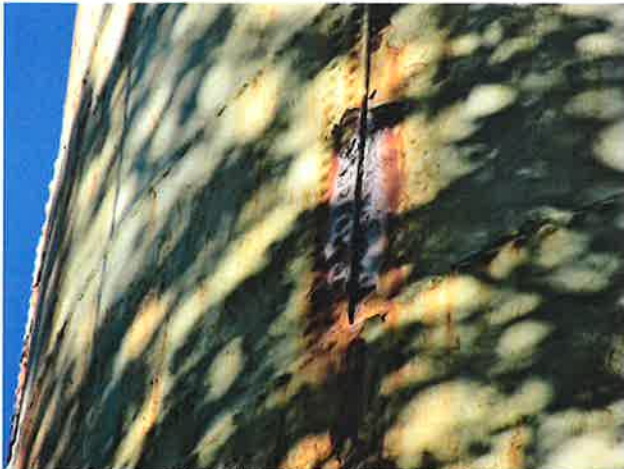
15 *Exterior Wall With Expired Coating/Peeling, Exposed Underlying Steel, Blotch Rusting, Mild To Moderate Surface Corrosion, Corrosive Staining, Rust Staining And Mildew*

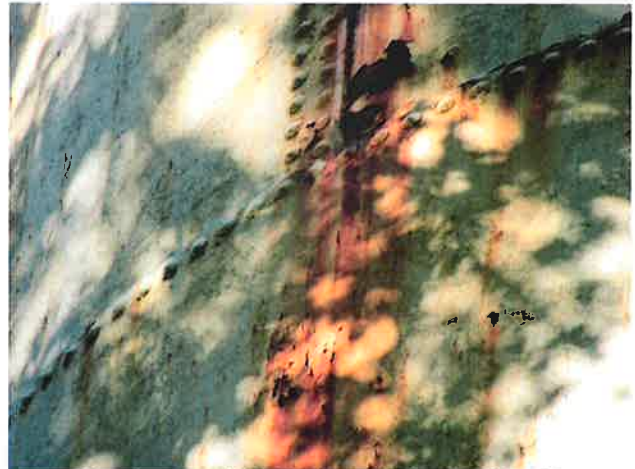
16 *Exterior Wall With Expired Coating/Peeling, Exposed Underlying Steel, Blotch Rusting, Mild To Moderate Surface Corrosion, Corrosive Staining, Rust Staining And Mildew*

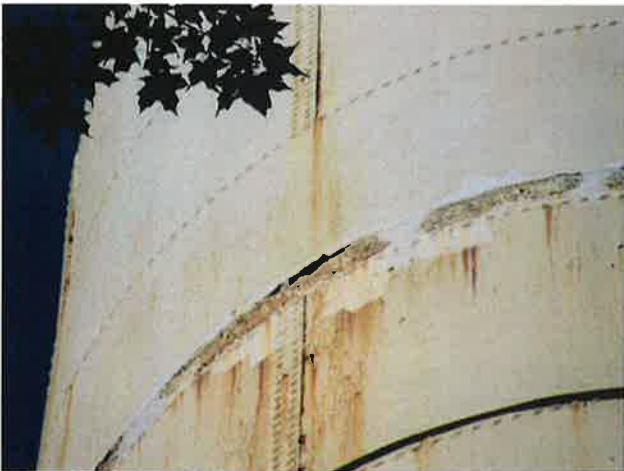
17 *Exterior Wall With Expired Coating/Peeling, Exposed Underlying Steel, Blotch Rusting, Mild To Moderate Surface Corrosion, Corrosive Staining, Rust Staining And Mildew*

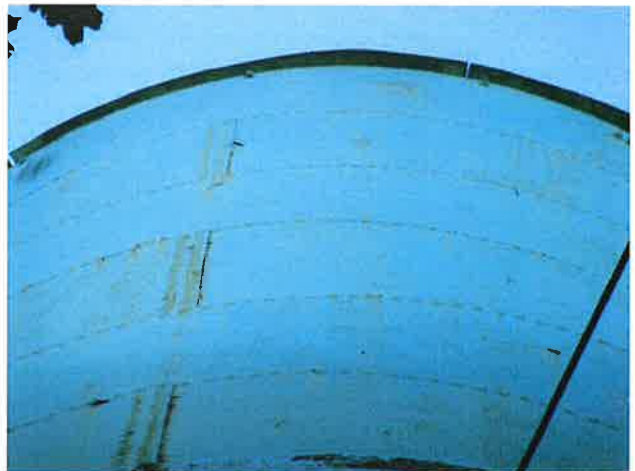
18 *Exterior Wall With Expired Coating/Peeling, Exposed Underlying Steel, Blotch Rusting, Mild To Moderate Surface Corrosion, Corrosive Staining, Rust Staining And Mildew*

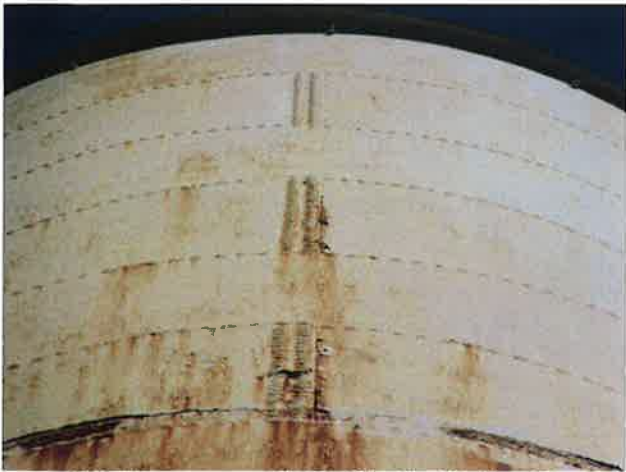
19 *Exterior Wall With Expired Coating/Peeling, Exposed Underlying Steel, Blotch Rusting, Mild To Moderate Surface Corrosion, Corrosive Staining, Rust Staining And Mildew*

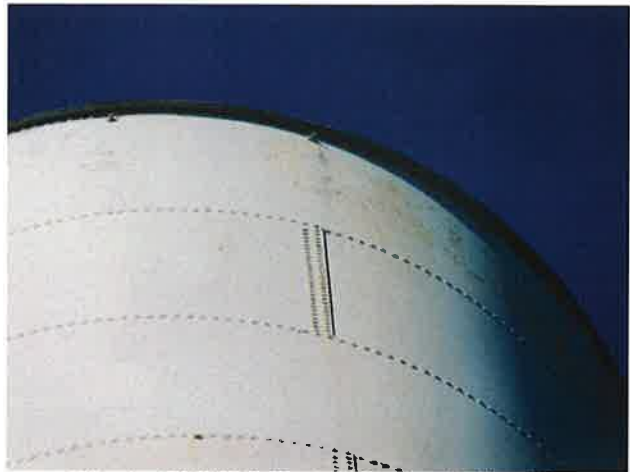
20 *Exterior Wall With Expired Coating/Peeling, Exposed Underlying Steel, Blotch Rusting, Mild To Moderate Surface Corrosion, Corrosive Staining, Rust Staining And Mildew*

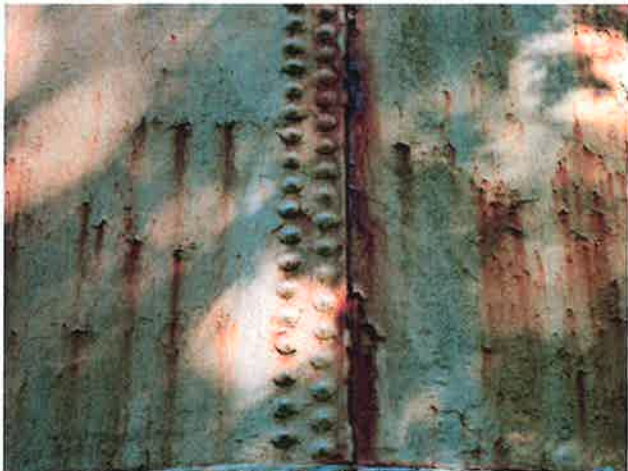
21 *Exterior Wall Third Row Vertical Lap Joint (East Side) Found Appearing Damp And Moist*

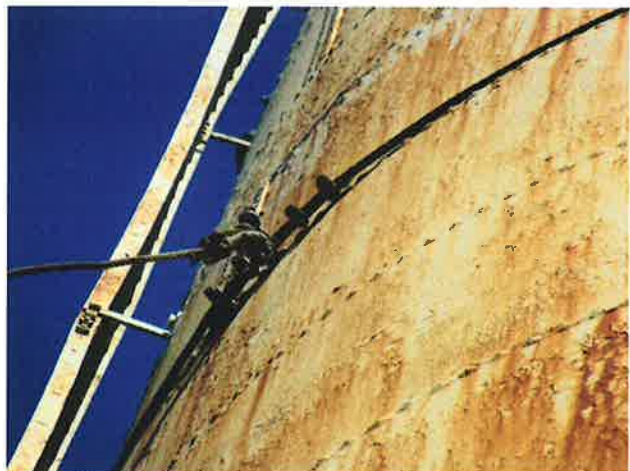
22 *Exterior Wall With A Support Cable*

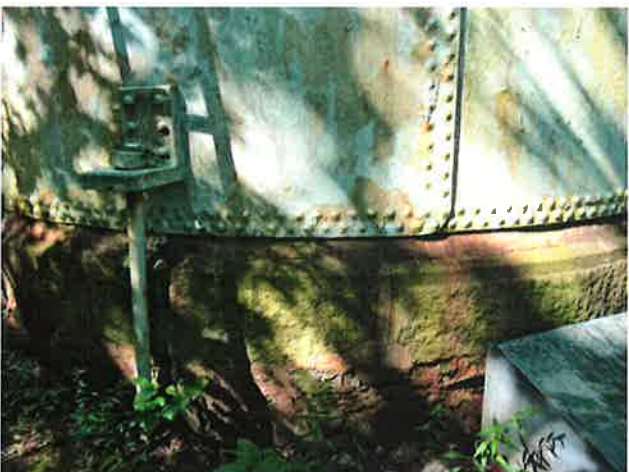
29 *Granite Block And Stone Foundation*

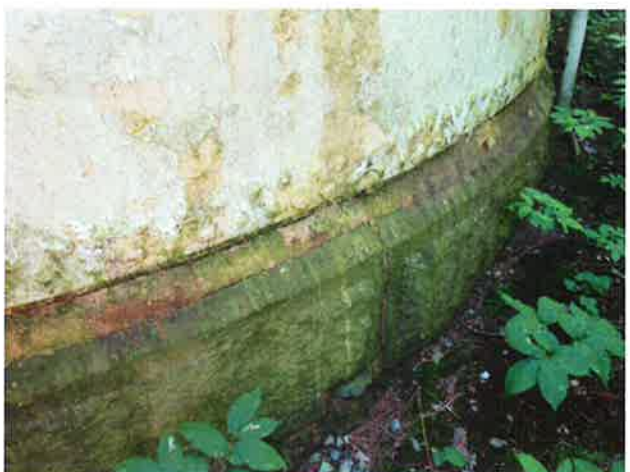
30 *Granite Block And Stone Foundation*

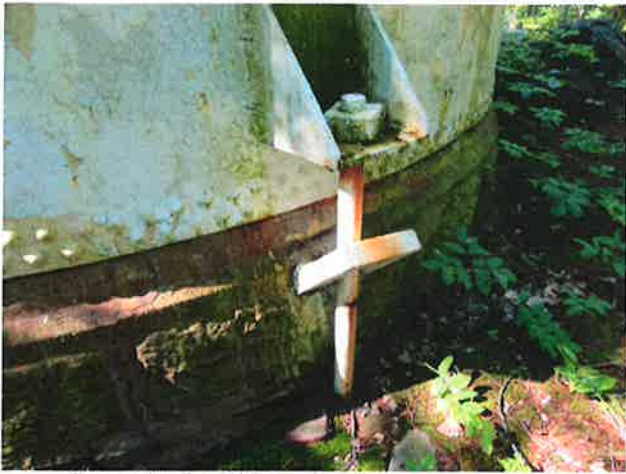
31 *Secure Anchor Bolt With Coating Loss*

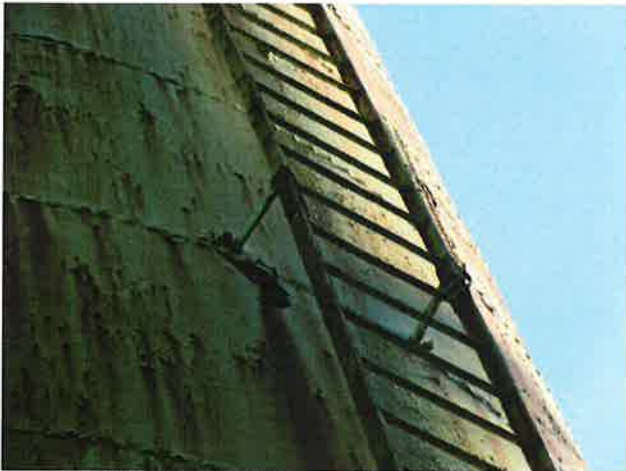
33 *Ladder With Coating Loss (Nearing Expiration), Exposed Underlying Steel And Mild Corrosion*

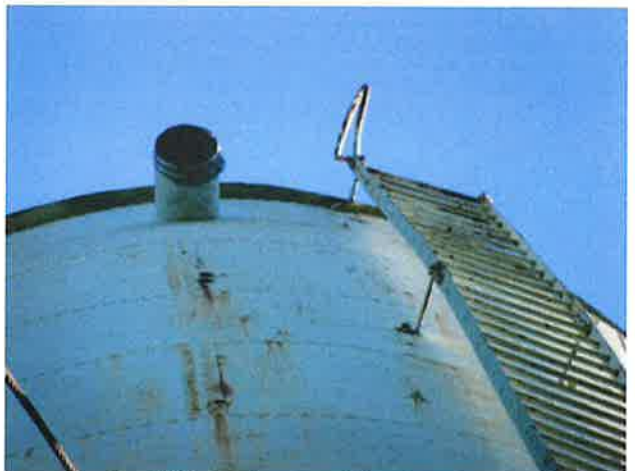
34 *Ladder With Coating Loss (Nearing Expiration), Exposed Underlying Steel And Mild Corrosion*

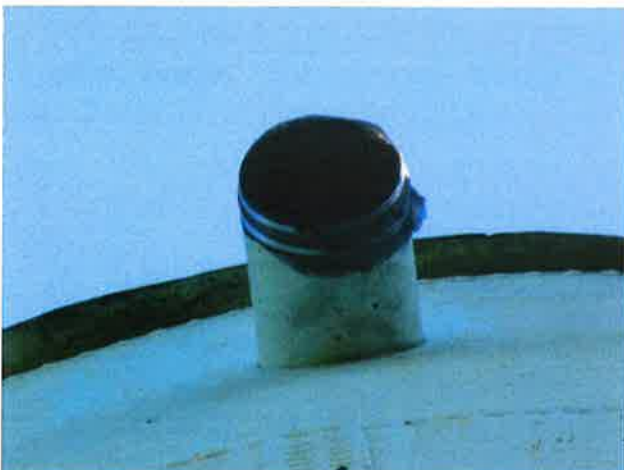
35 *Secure Overflow Pipe Screen*

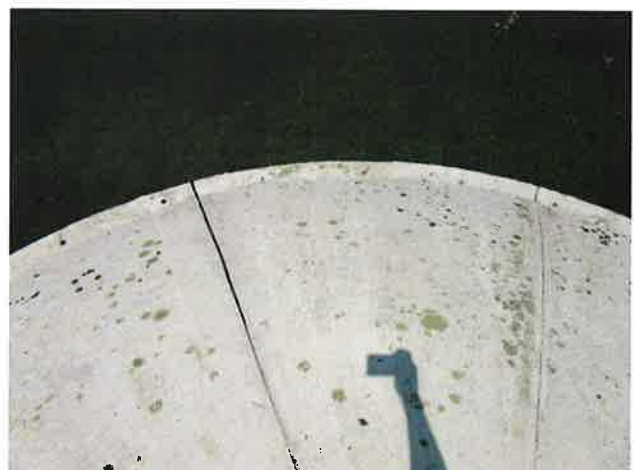
36 *Roof Panel Joints Sealant Found Deteriorating*

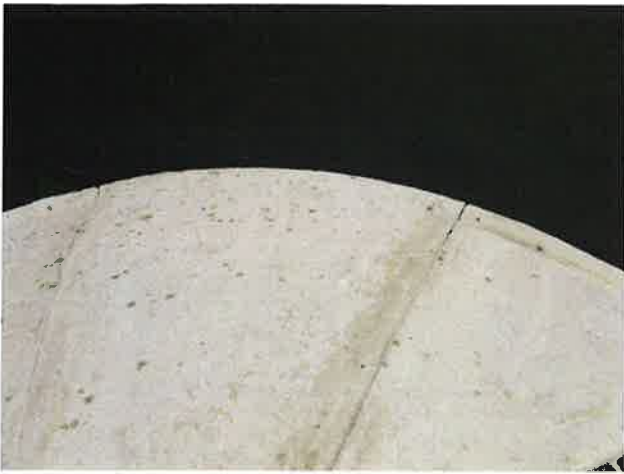
37 *Roof Panel Joints Sealant Found Deteriorating*

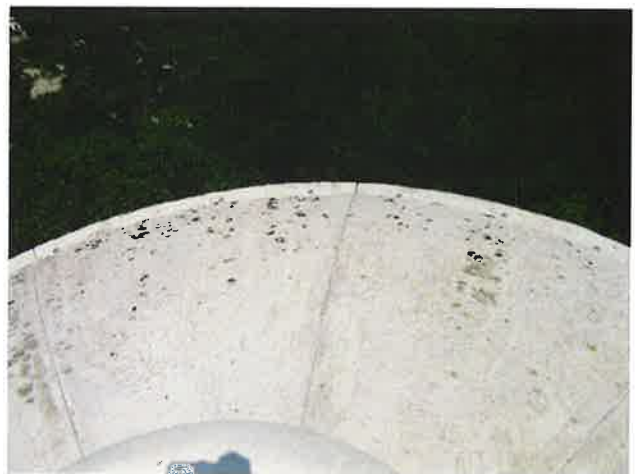
38 *Roof Panel Joints Sealant Found Deteriorating*

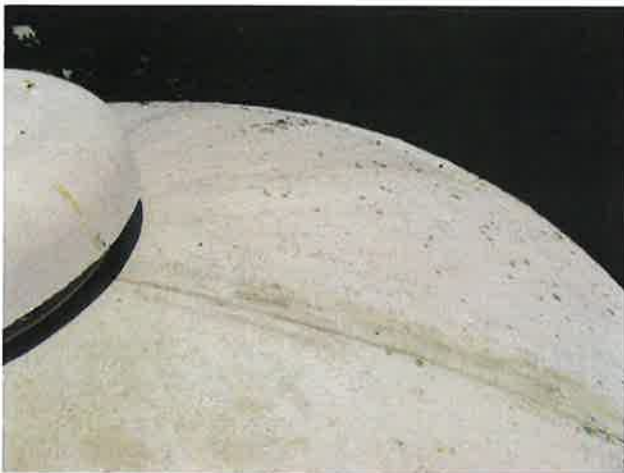
39 *Roof Panel Joints Sealant Found Deteriorating*

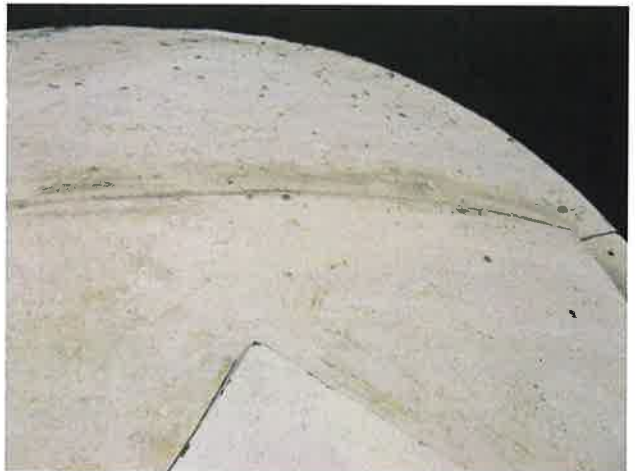
40 *Roof Panel Joints Sealant Found Deteriorating*

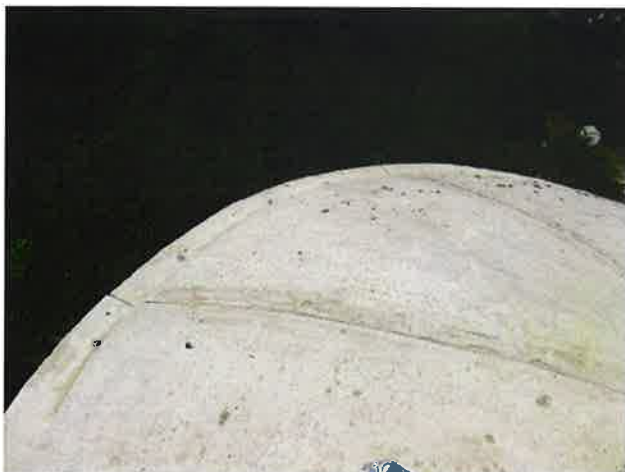
41 *Roof Panel Joints Sealant Found Deteriorating*

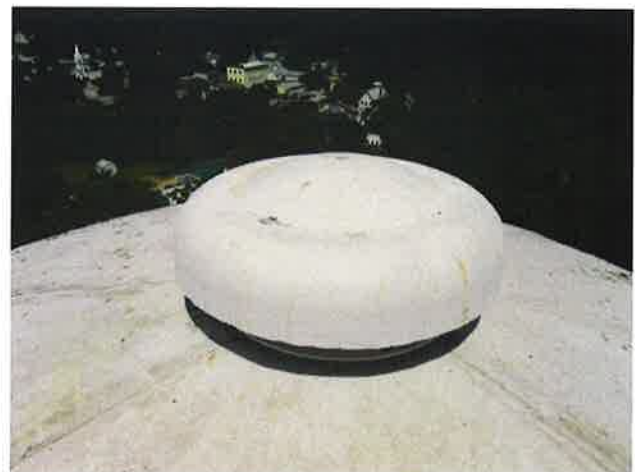
42 *Secure Vent Cap*

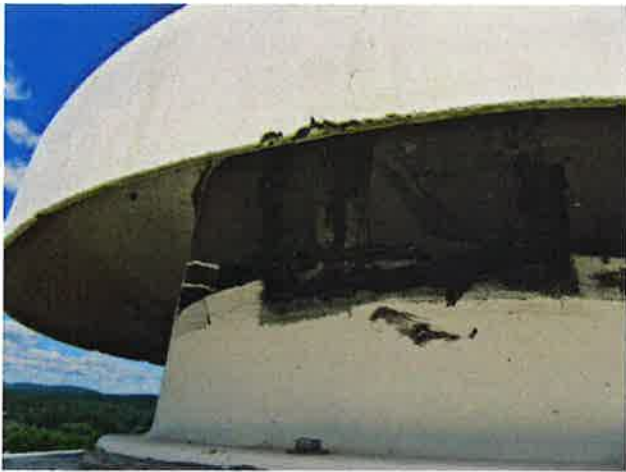
43 *Vent Screen Found Torn*

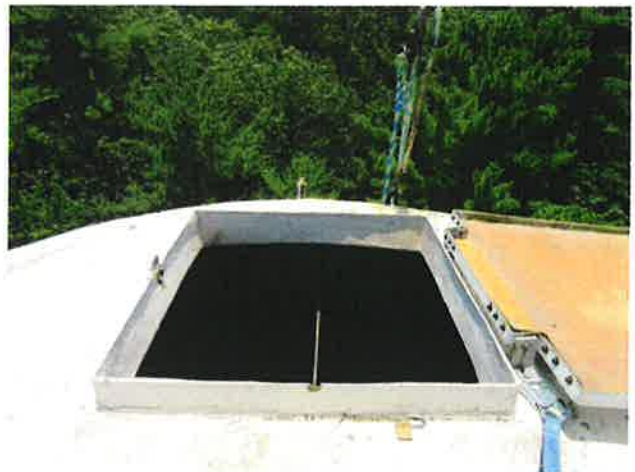
44 *Open Access Hatch*

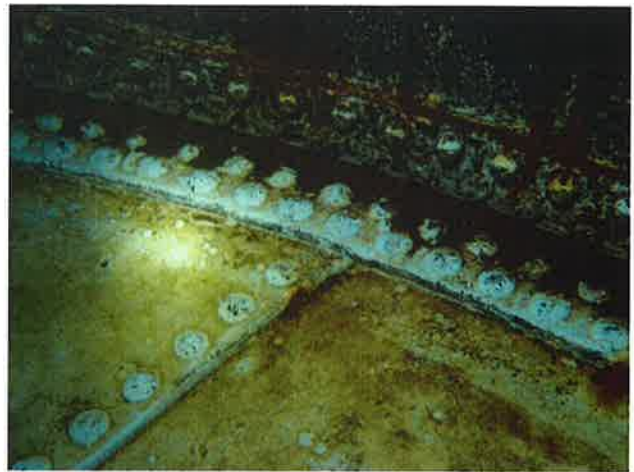
50 *Floor With Mild Staining*

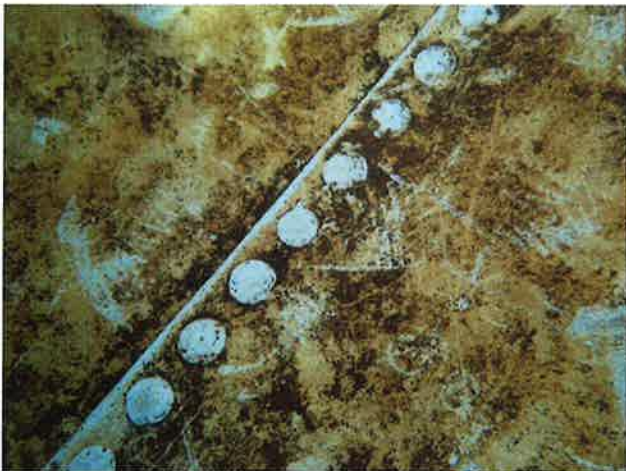
51 *Floor With Mild Staining*

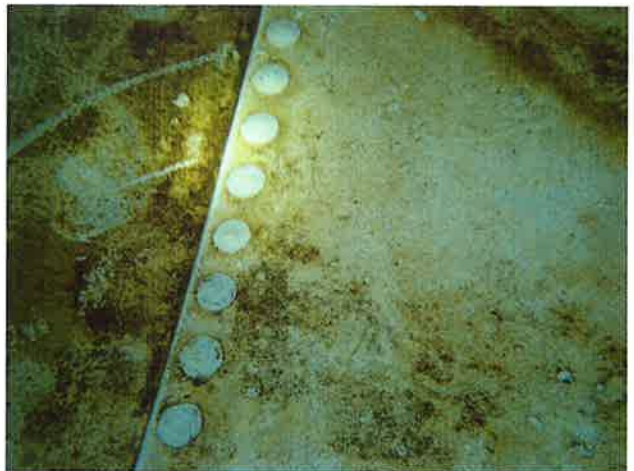
52 *Floor With Mild Staining*

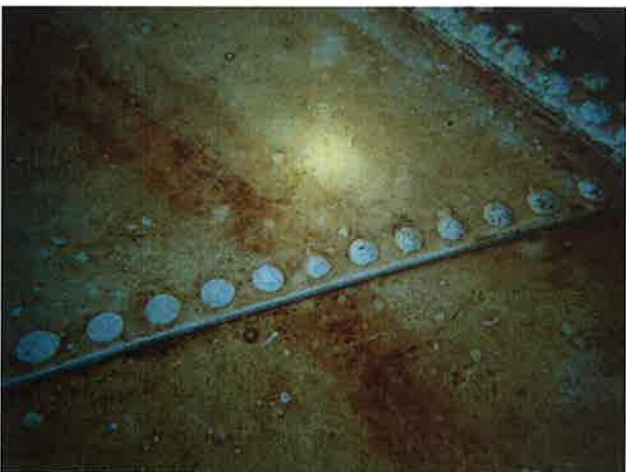
53 *Floor With Mild Staining*

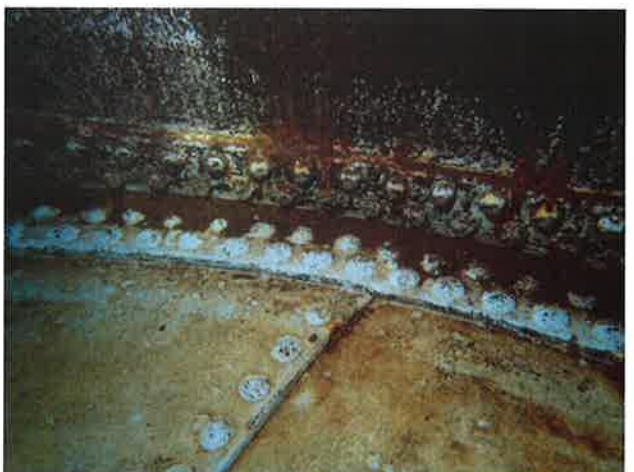
54 *Floor With Mild Staining*

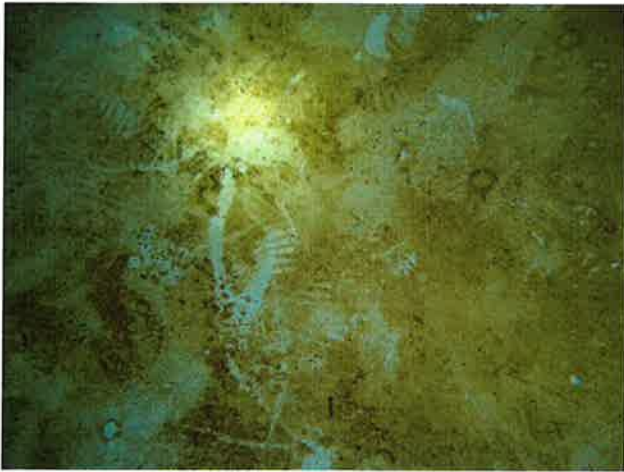
55 *Floor With Mild Staining*

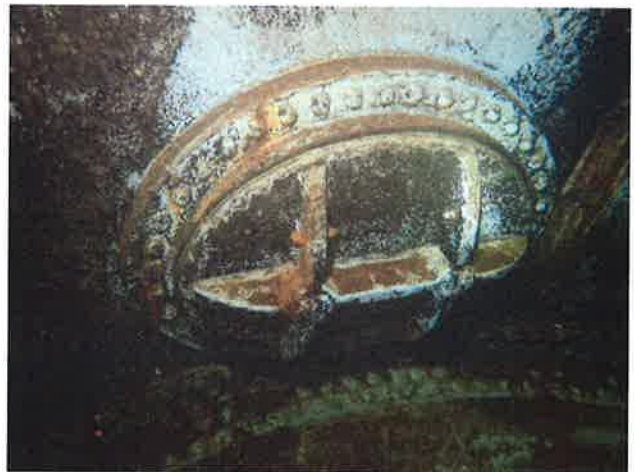
56 *Manway Rivets With Coating Loss And Mild Corrosion*

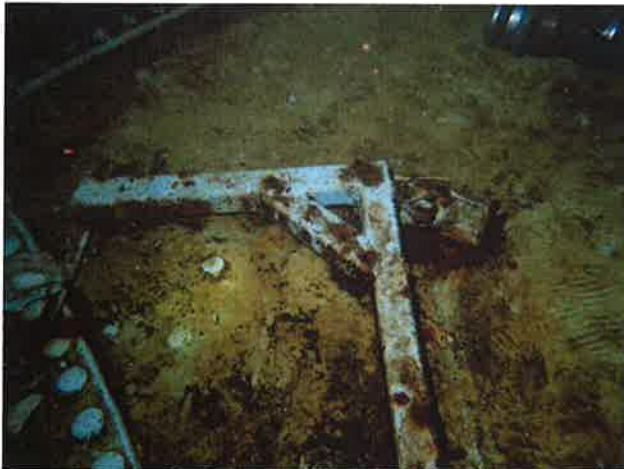
57 *Manway Steel Support Laying On The Tank Floor*

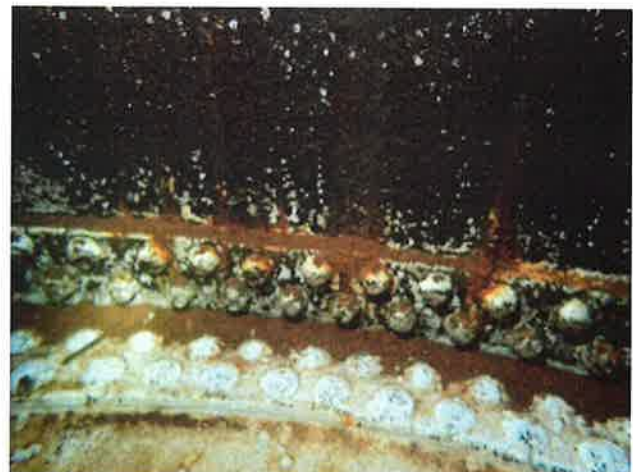
60 *Interior Wall With Coating Loss (Nearing Expiration), Blotch Rusting, Exposed Underlying Steel, Moderate Surface Corrosion And Heavy Staining*

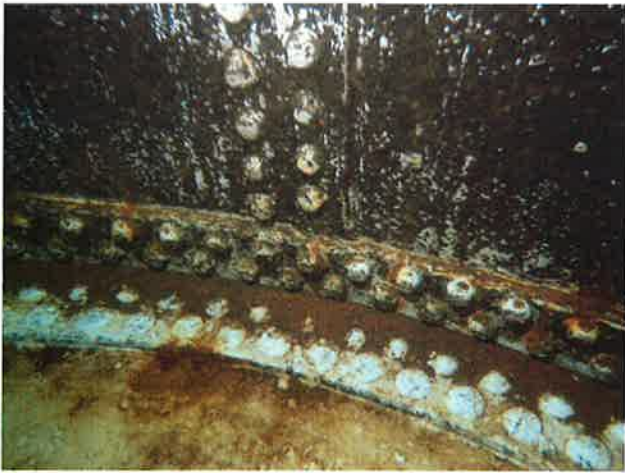
61 *Interior Wall With Coating Loss (Nearing Expiration), Blotch Rusting, Exposed Underlying Steel, Moderate Surface Corrosion And Heavy Staining*

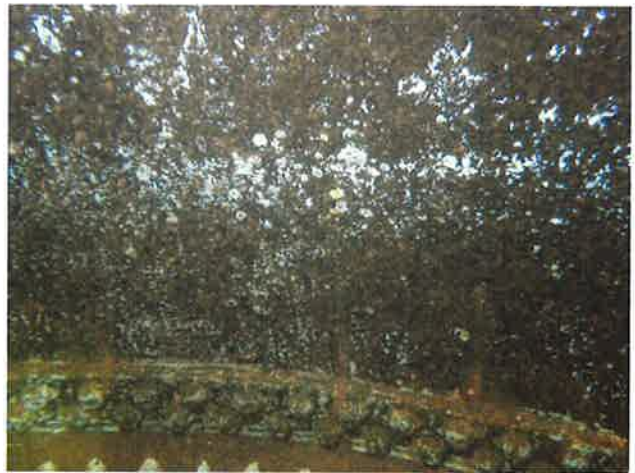
62 *Interior Wall With Coating Loss (Nearing Expiration), Blotch Rusting, Exposed Underlying Steel, Moderate Surface Corrosion And Heavy Staining*

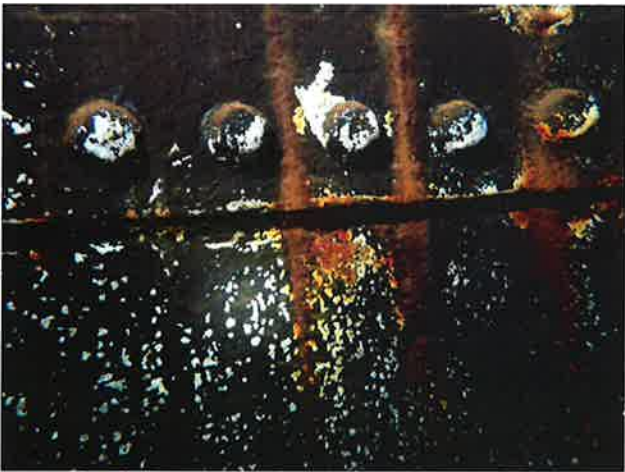
63 *Interior Wall With Coating Loss (Nearing Expiration), Blotch Rusting, Exposed Underlying Steel, Moderate Surface Corrosion And Heavy Staining*

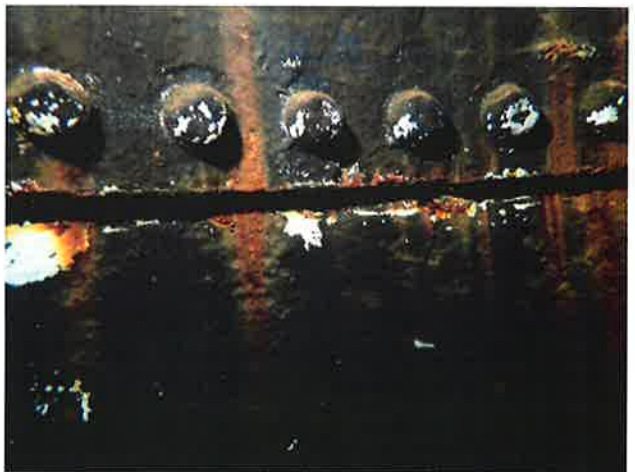
64 *Interior Wall With Coating Loss (Nearing Expiration), Blotch Rusting, Exposed Underlying Steel, Moderate Surface Corrosion And Heavy Staining*

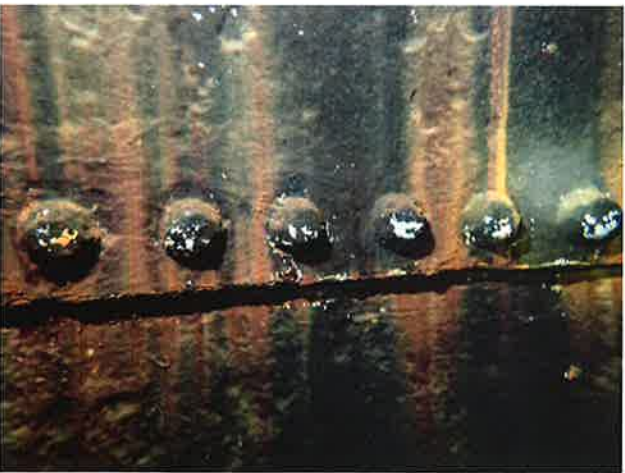
65 *Interior Wall With Coating Loss (Nearing Expiration), Blotch Rusting, Exposed Underlying Steel, Moderate Surface Corrosion And Heavy Staining*

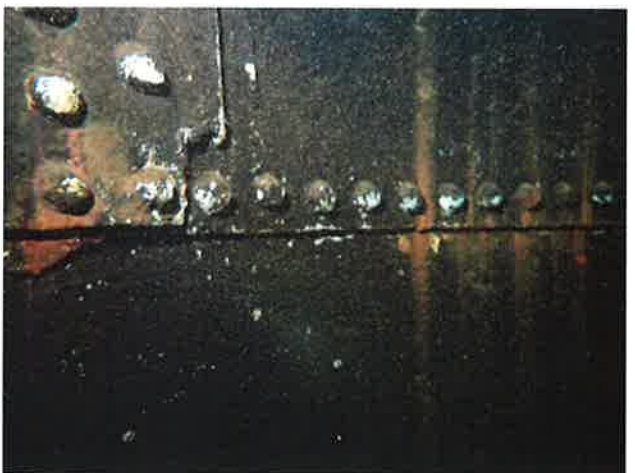
66 *Interior Wall With Coating Loss (Nearing Expiration), Blotch Rusting, Exposed Underlying Steel, Moderate Surface Corrosion And Heavy Staining*

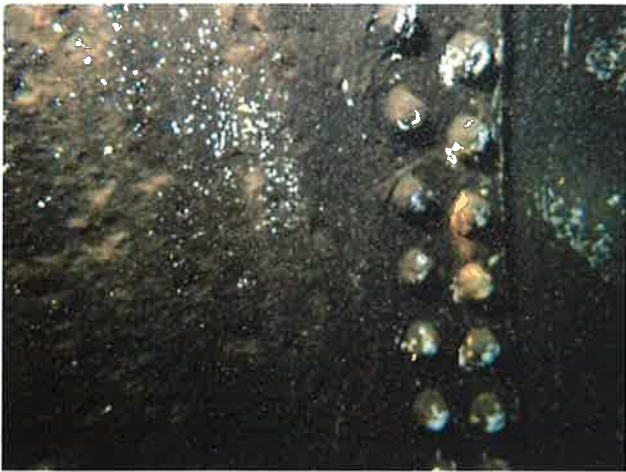
67 *Interior Wall With Coating Loss (Nearing Expiration), Blotch Rusting, Exposed Underlying Steel, Moderate Surface Corrosion And Heavy Staining*
