January 31, 2020

100 International Drive, Suite 152, Portsmouth, NH 03801
Tel: 603.431.3937

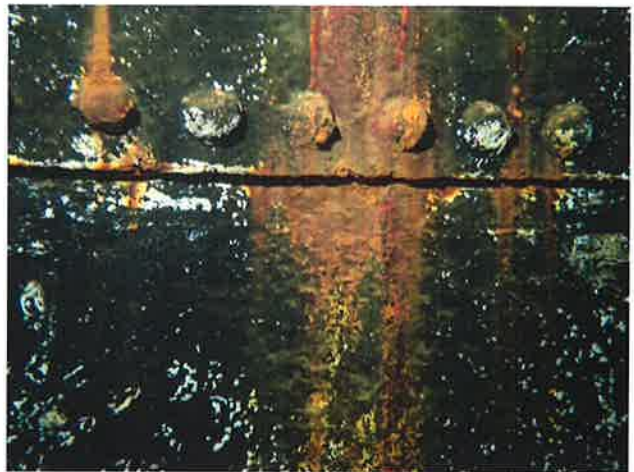
68 *Interior Wall With Coating Loss (Nearing Expiration), Blotch Rusting, Exposed Underlying Steel, Moderate Surface Corrosion And Heavy Staining*

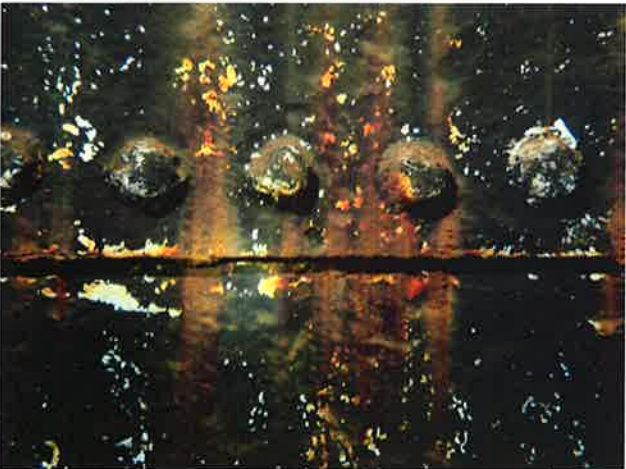
69 *Interior Wall With Coating Loss (Nearing Expiration), Blotch Rusting, Exposed Underlying Steel, Moderate Surface Corrosion And Heavy Staining*

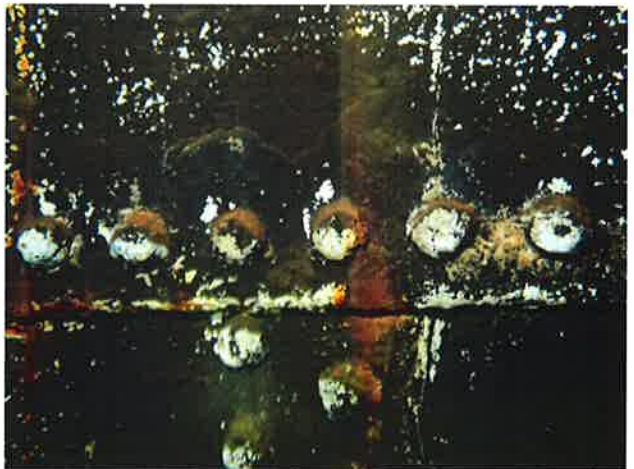
70 *Interior Wall With Coating Loss (Nearing Expiration), Blotch Rusting, Exposed Underlying Steel, Moderate Surface Corrosion And Heavy Staining*

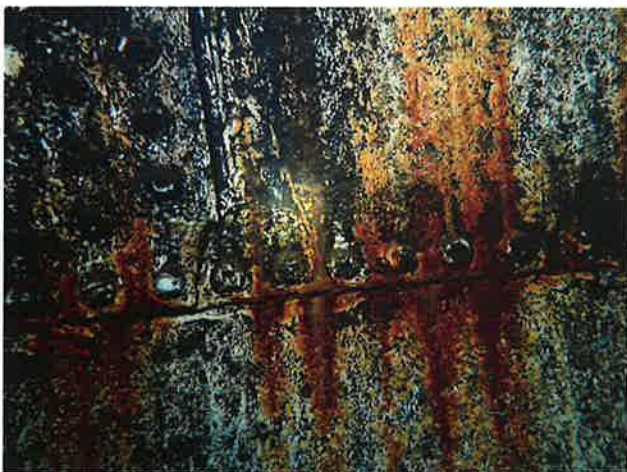
71 *Interior Wall With Coating Loss (Nearing Expiration), Blotch Rusting, Exposed Underlying Steel, Moderate Surface Corrosion And Heavy Staining*

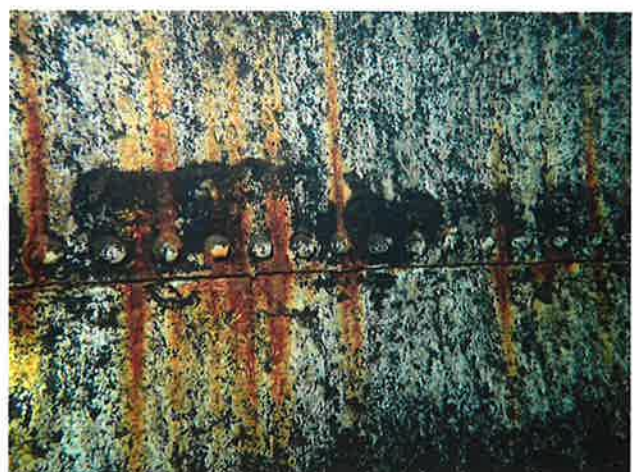
72 *Interior Wall With Coating Loss (Nearing Expiration), Blotch Rusting, Exposed Underlying Steel, Moderate Surface Corrosion And Heavy Staining*

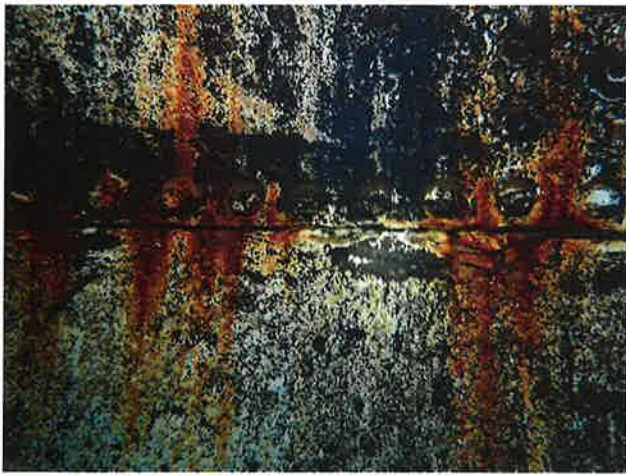
73 *Interior Wall With Coating Loss (Nearing Expiration), Blotch Rusting, Exposed Underlying Steel, Moderate Surface Corrosion And Heavy Staining*

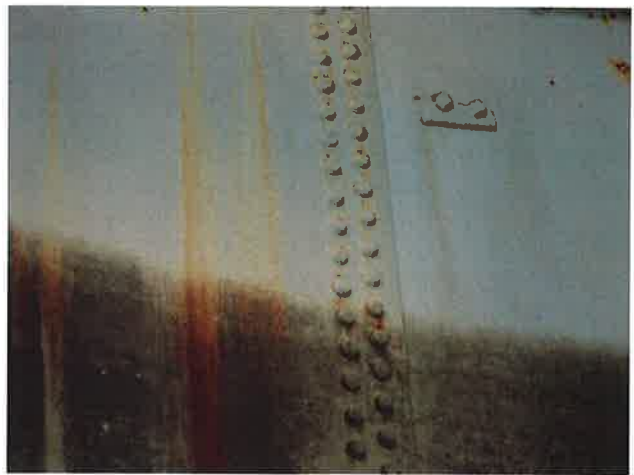
74 *Interior Wall With Ruptured Coating Blisters, Exposed Underlying Steel, Mild To Moderate Surface Corrosion And Heavy Staining*

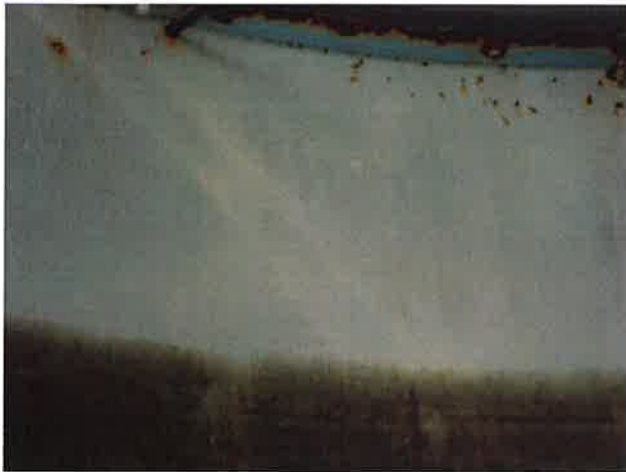
75 *Interior Wall With Ruptured Coating Blisters, Exposed Underlying Steel, Mild To Moderate Surface Corrosion And Heavy Staining*

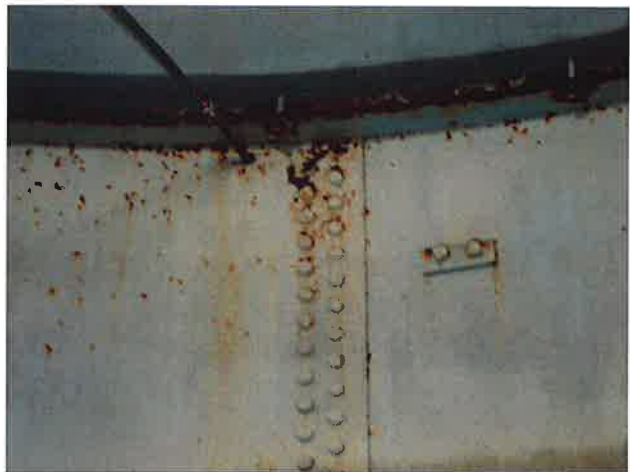
76 *Interior Wall With Ruptured Coating Blisters, Exposed Underlying Steel, Mild To Moderate Surface Corrosion And Heavy Staining*

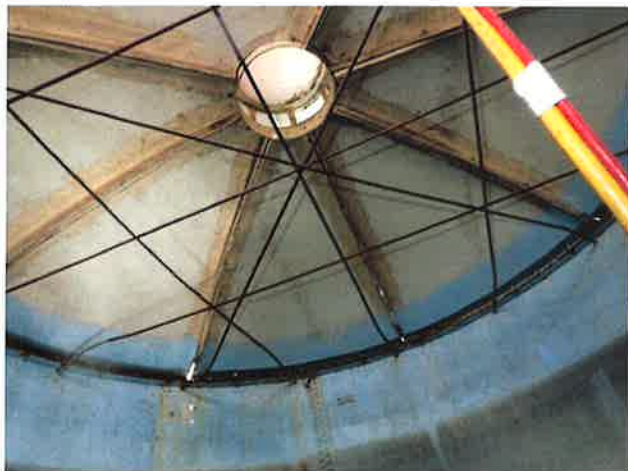
81 *Overhead Spider Supports With Mild Surface Corrosion*

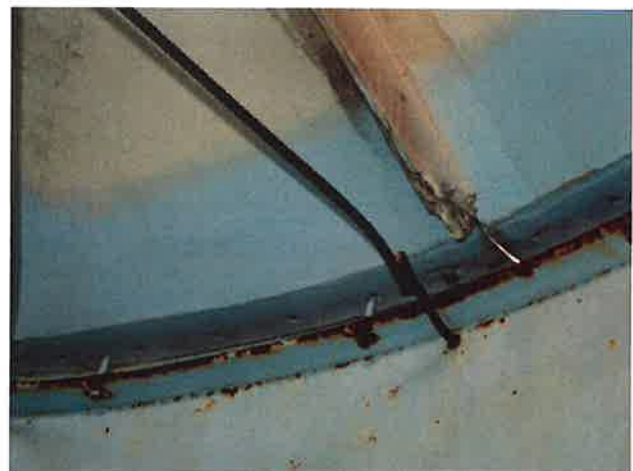
82 *Overhead Spider Supports With Mild Surface Corrosion*

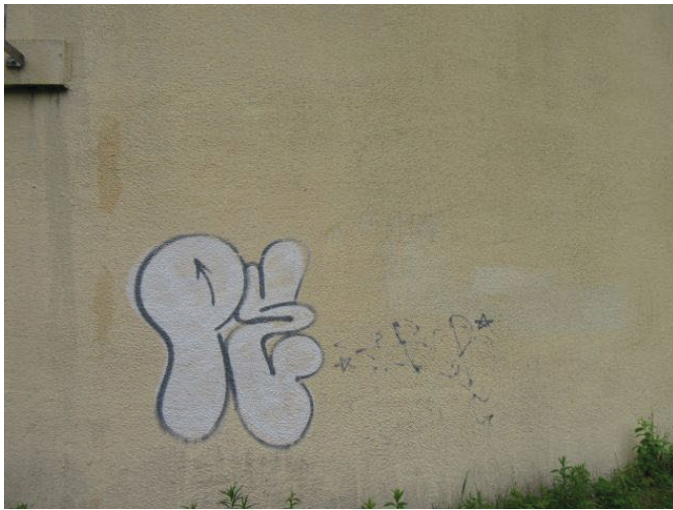
1 *Exterior Wall With Spray-Painted Graffiti*

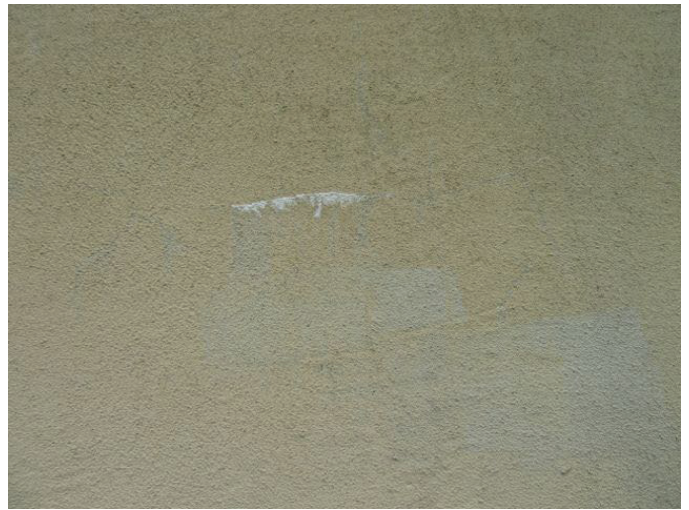
2 *Exterior Wall With Coating Loss, Tight Shrinkage Cracks, Efflorescence And Mildew*

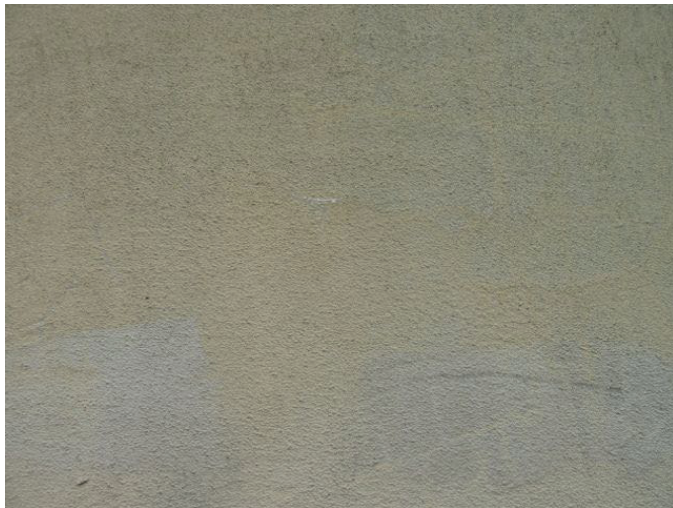
3 *Exterior Wall With Coating Loss, Tight Shrinkage Cracks, Efflorescence And Mildew*

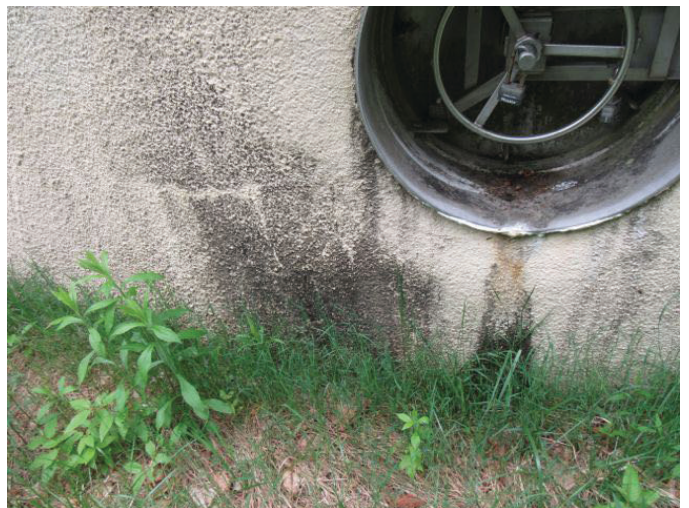
4 *Exterior Wall With Coating Loss, Tight Shrinkage Cracks, Efflorescence And Mildew*

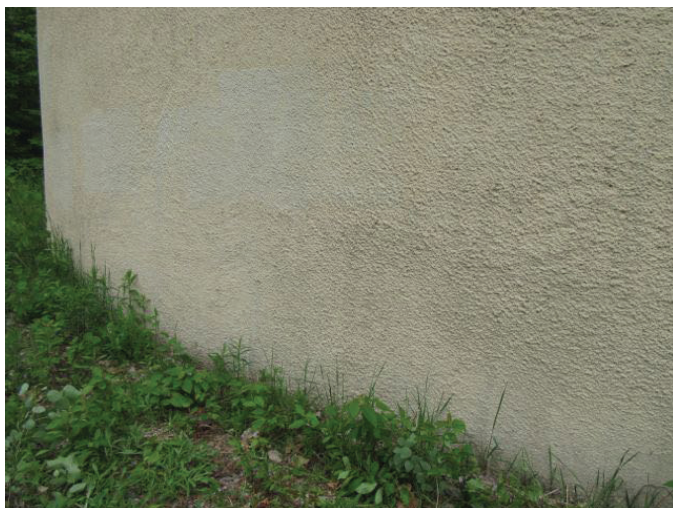
5 *Exterior Wall With Mild Mildew*

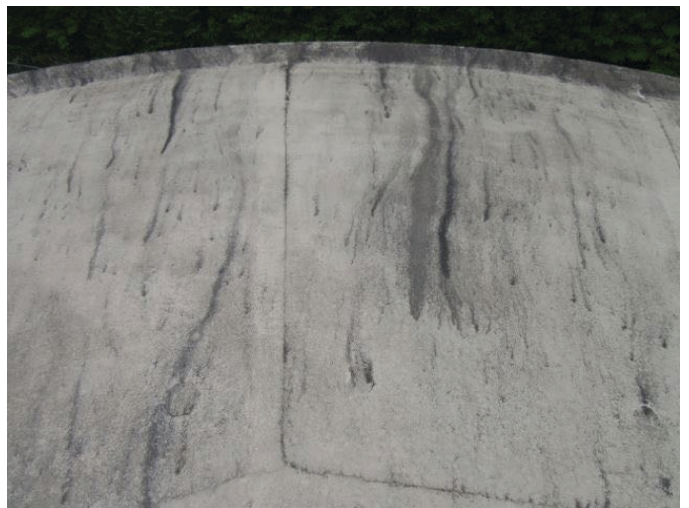
18 *Roof Dome Concrete Filled Joints With Coating Loss, Tight Cracks And Mildew*

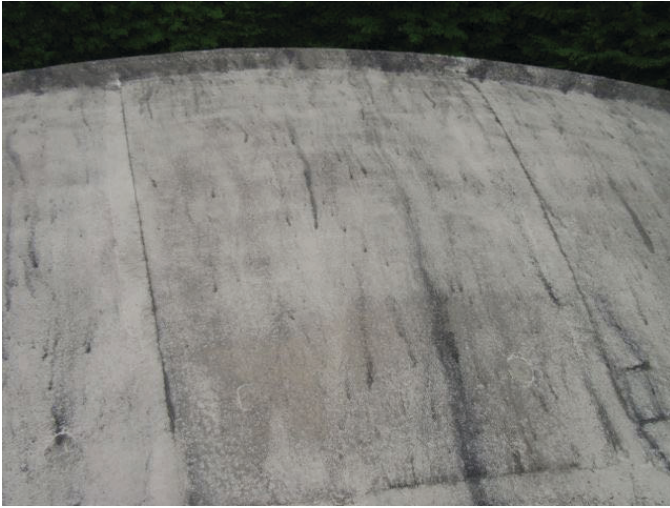
19 *Roof Dome Concrete Filled Joints With Coating Loss, Tight Cracks And Mildew*

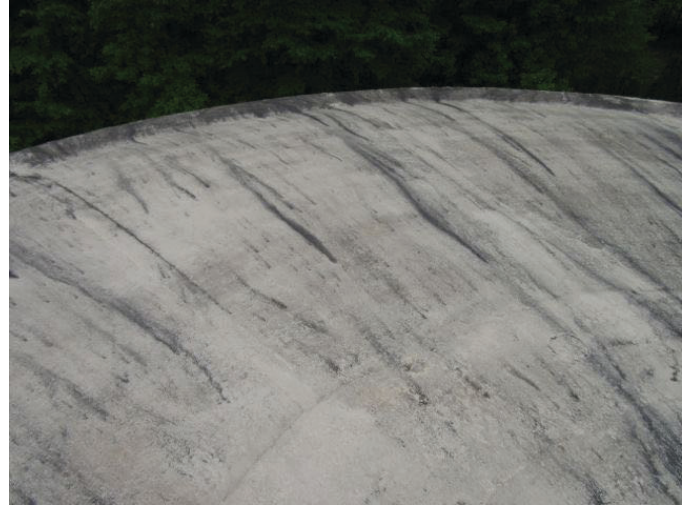
20 *Roof Dome Concrete Filled Joints With Coating Loss, Tight Cracks And Mildew*

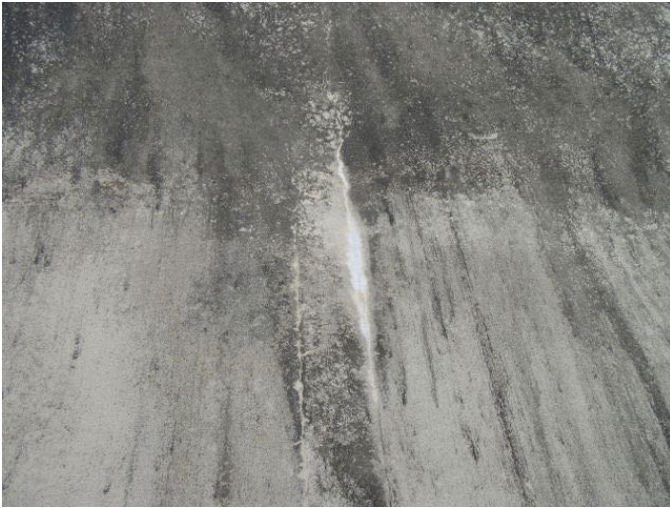
21 *Roof Dome Concrete Filled Joints With Coating Loss, Tight Cracks And Mildew*

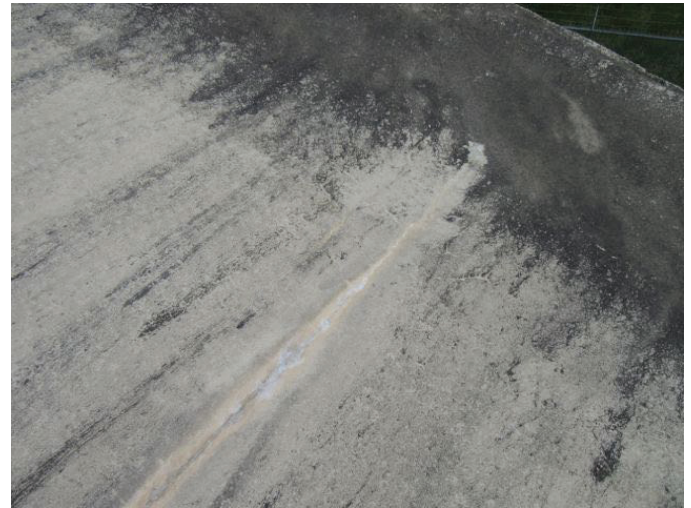
22 *Roof Dome Concrete Filled Joints With Coating Loss, Tight Cracks And Mildew*

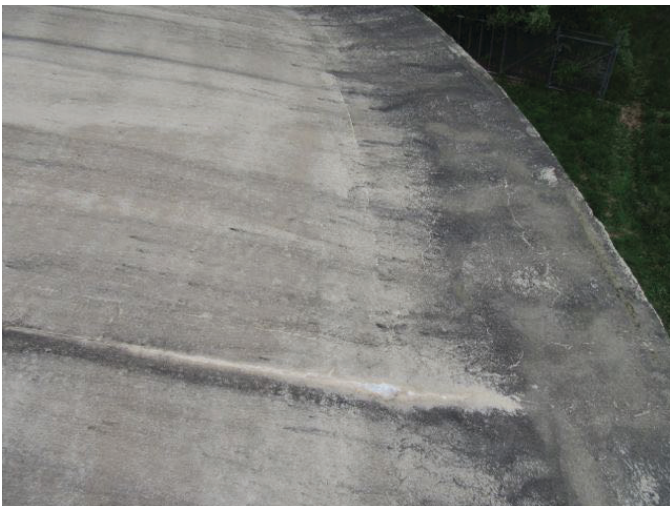
23 *Roof Dome Concrete Filled Joints With Coating Loss, Tight Cracks And Mildew*

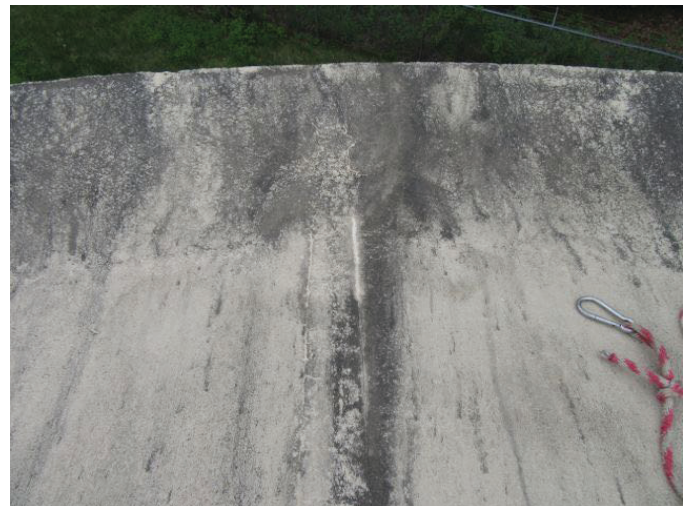
24 *Roof Dome Concrete Filled Joints With Coating Loss, Tight Cracks And Mildew*

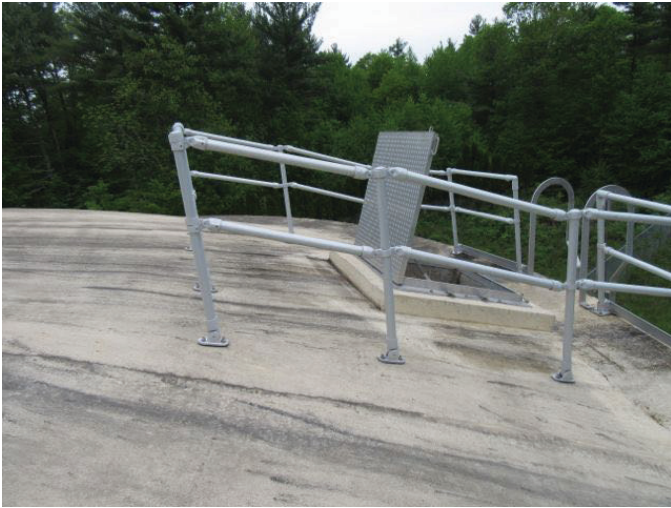
25 *Secure Safety Railing*

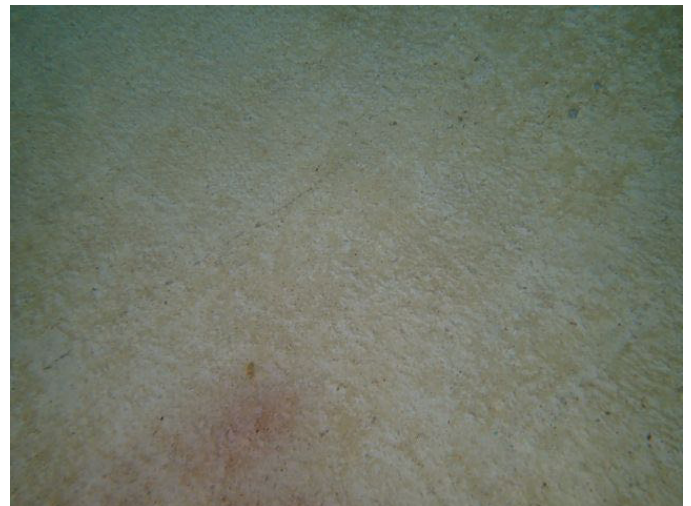
36 *Floor With Mild Staining*

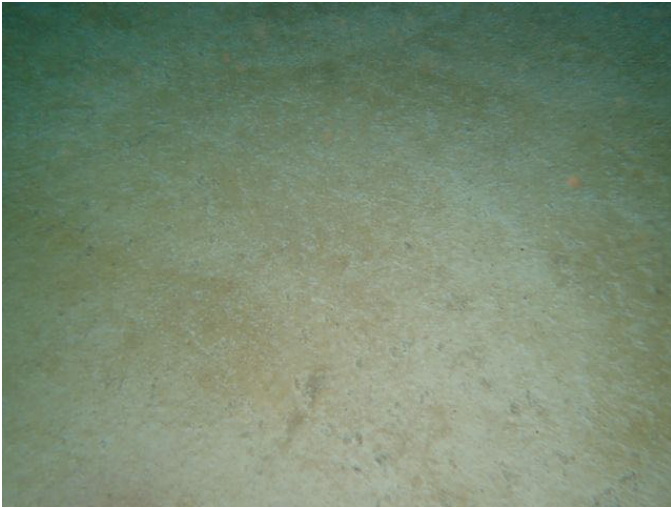
37 *Floor With Mild Staining*

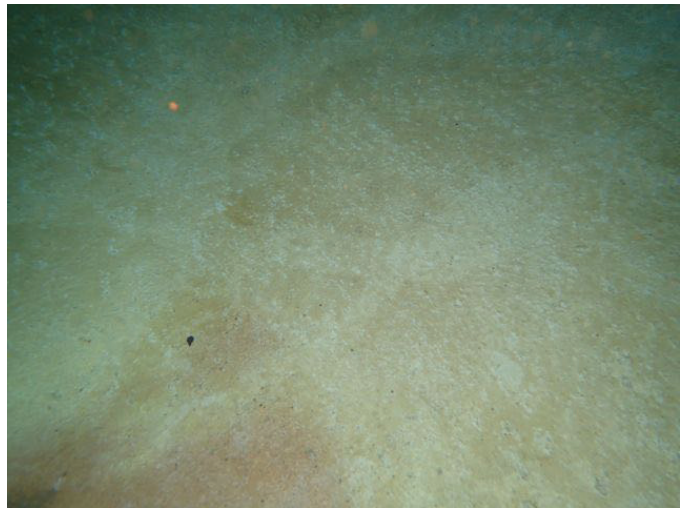
38 *Floor With Mild Staining*

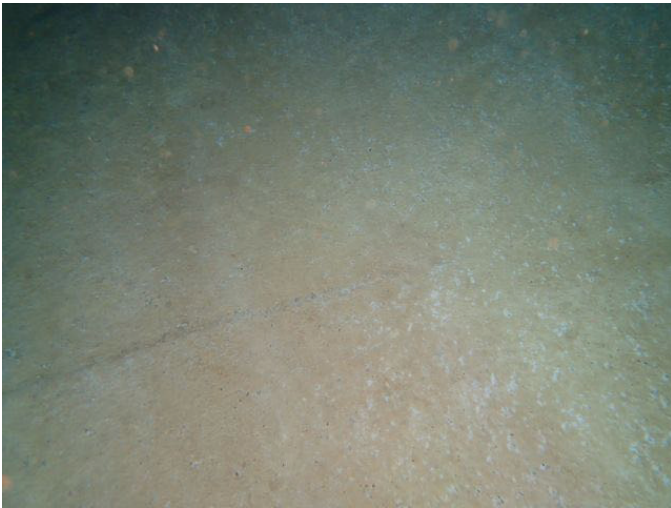
39 *Floor With Mild Staining*

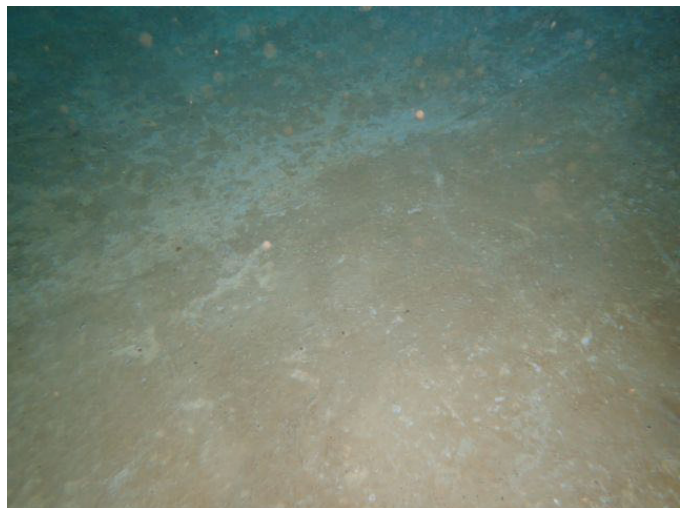
40 *Floor With Mild Staining*

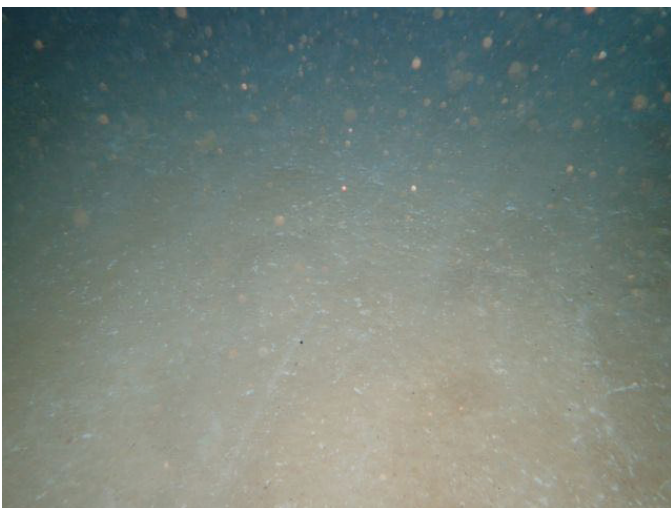
41 *Floor With Mild Staining*

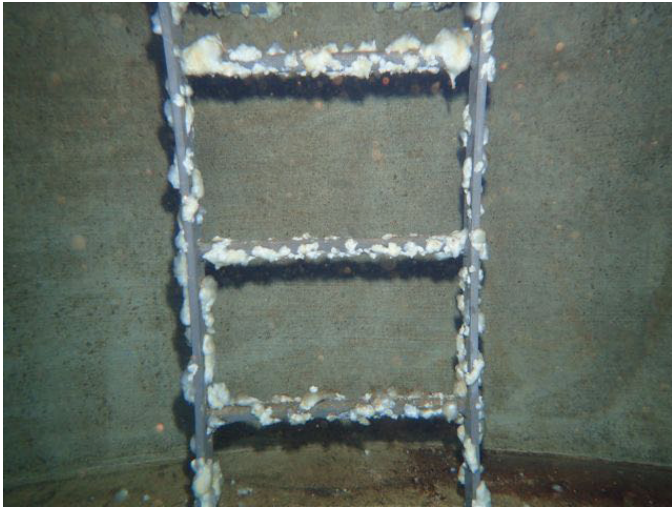
43 *Aluminum Manway Access Ladder With Corrosion*

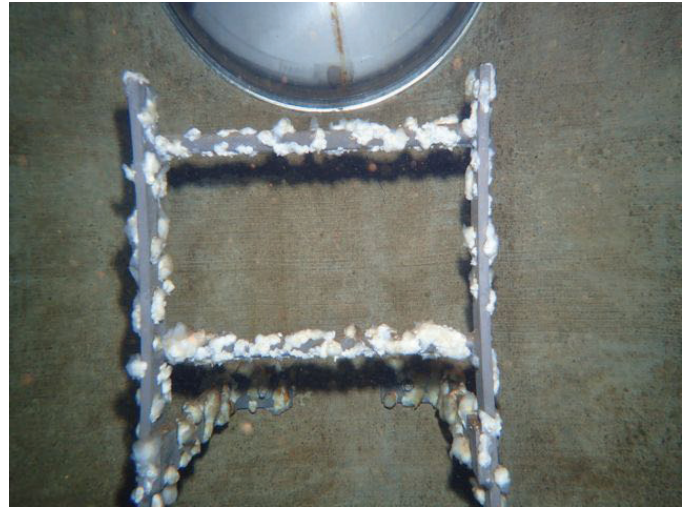
44 *Aluminum Manway Access Ladder With Corrosion*

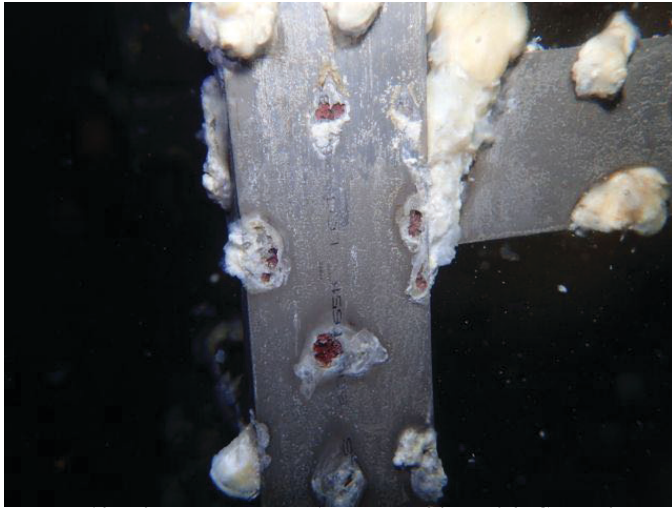
45 *Aluminum Manway Access Ladder With Corrosion And Fatigue (Pitting)*

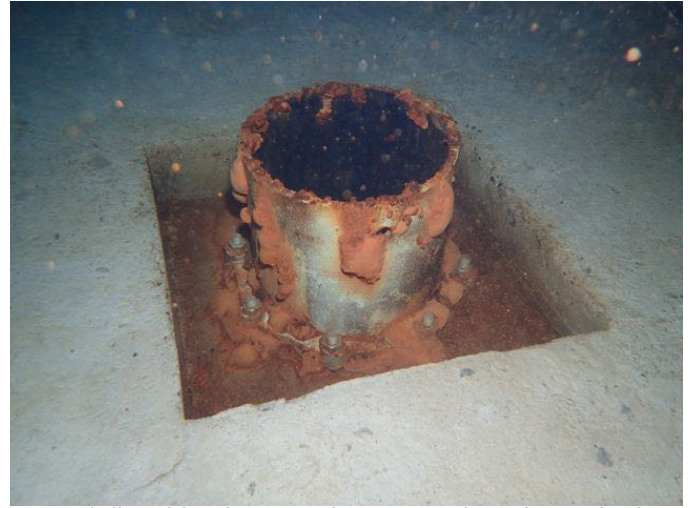
46 *14" Inside Diameter Pipe Penetrating The Tank Floor Within A Deep Sump With Coating Loss/Blistering, Exposed Metal And Corrosion*

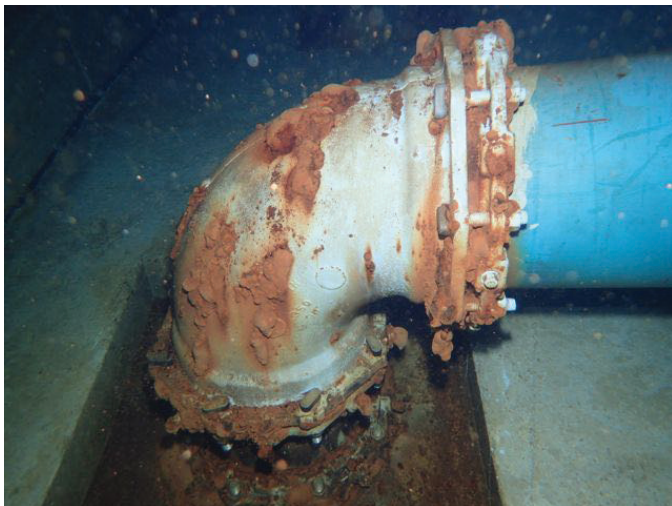
47 *12" Inside Diameter Pipe And Elbow With Coating Loss/Blistering, Exposed Metal And Corrosion*

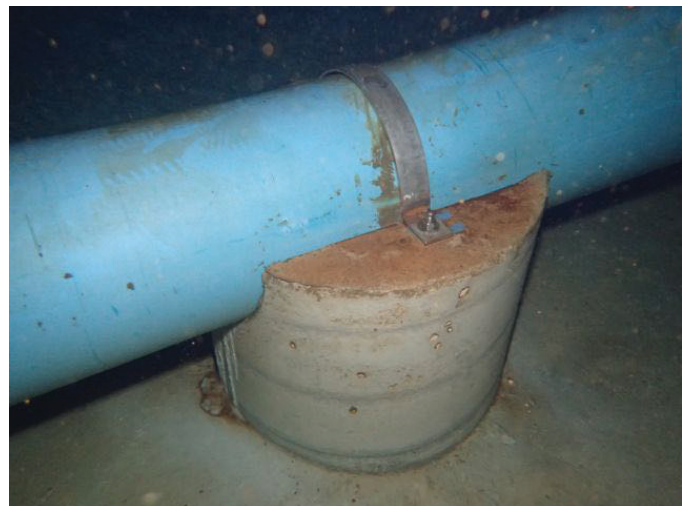
48 *12" Inside Diameter P.V.C. Pipe Supported To The Tank Floor With Coating Loss/Blistering, Exposed Metal And Corrosion*

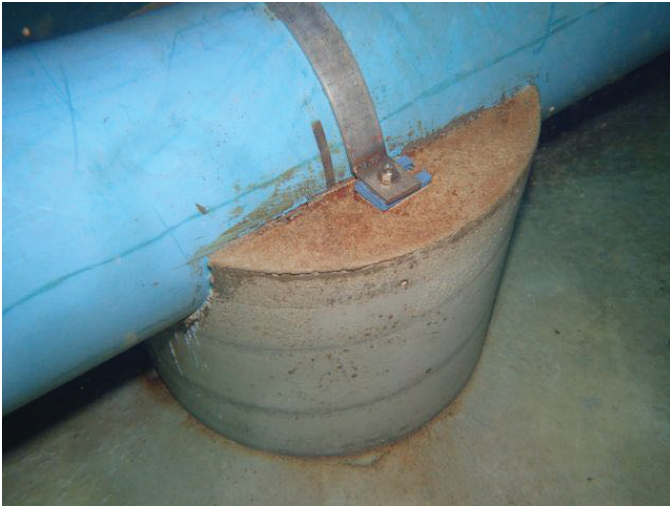
49 *12" Inside Diameter P.V.C. Pipe Supported To The Tank Floor With Coating Loss/Blistering, Exposed Metal And Corrosion*

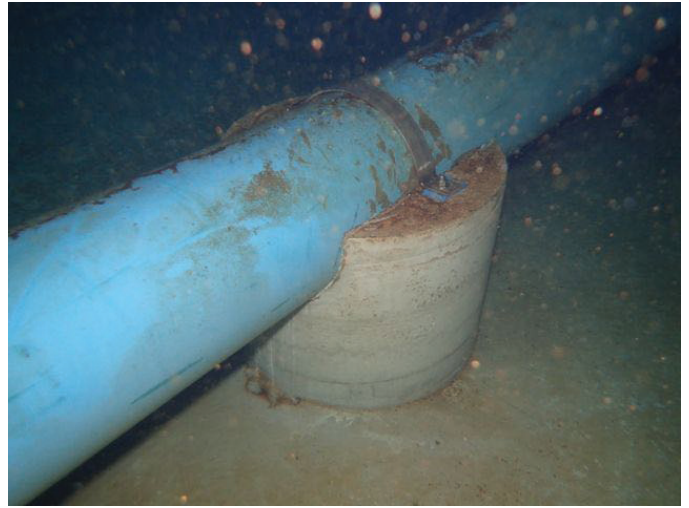
50 *12" Inside Diameter P.V.C. Pipe Supported To The Tank Floor With Coating Loss/Blistering, Exposed Metal And Corrosion*

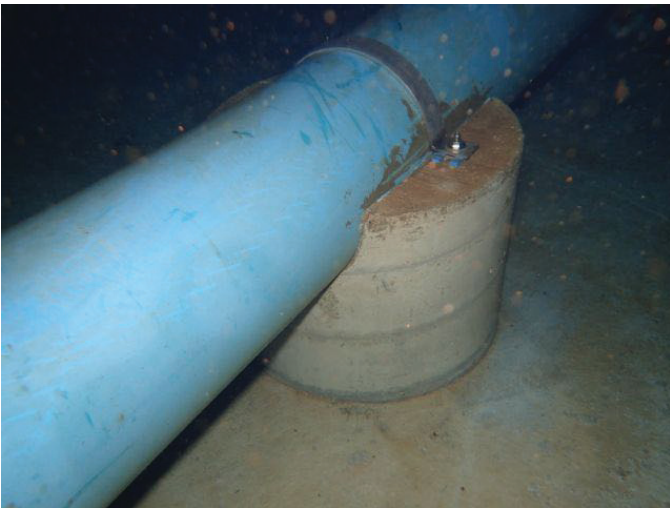
51 *12" Inside Diameter P.V.C. Pipe Supported To The Tank Floor With Coating Loss/Blistering, Exposed Metal And Corrosion*

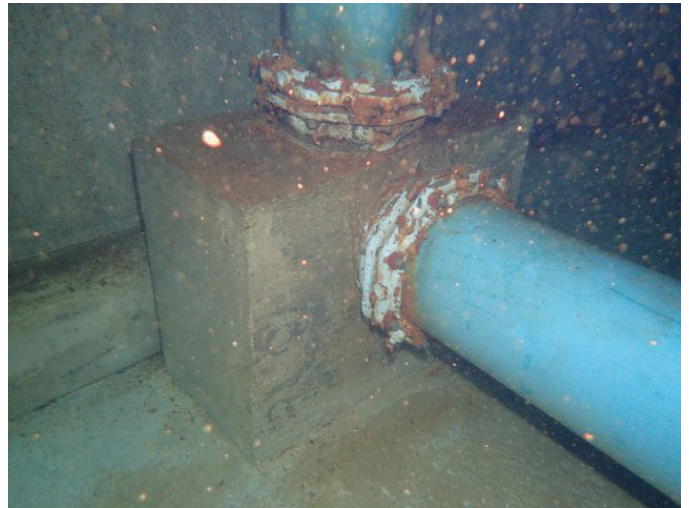
52 *12" Inside Diameter Pipe Elbow Encased In A Concrete Thrust Block*

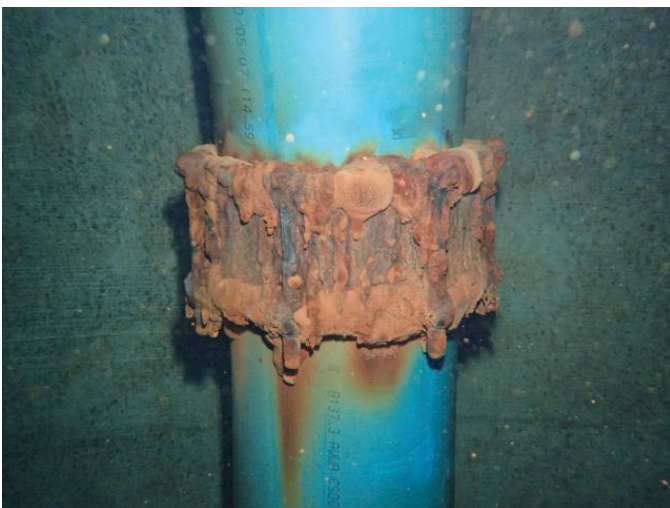
53 *12" Inside Diameter P.V.C. Piping Extending Through A Coupling With Coating Loss/Blistering, Exposed Metal And Corrosion*

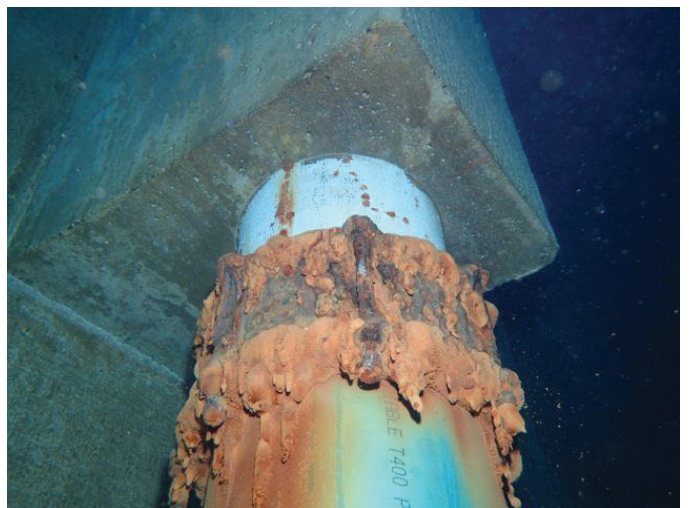
54 *12" Inside Diameter P.V.C. Piping Extending Through A Coupling And Penetrating A Concrete Box With Coating Loss/Blistering, Exposed Metal And Corrosion*

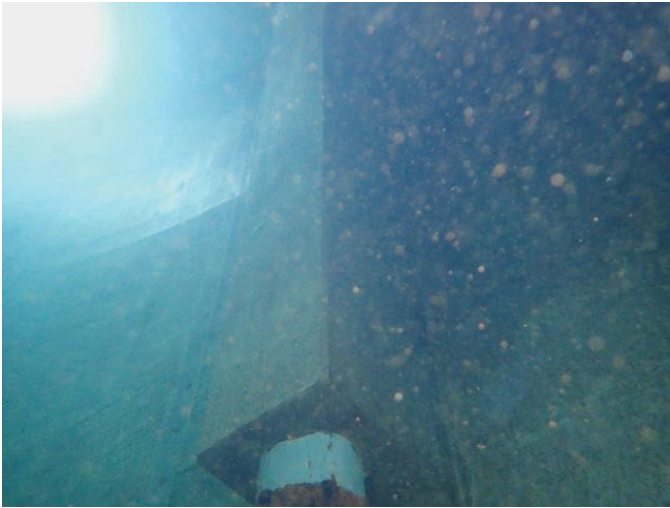
55 *Concrete Box Formed To The Tank Wall For The 12" Inside Diameter Pipe*

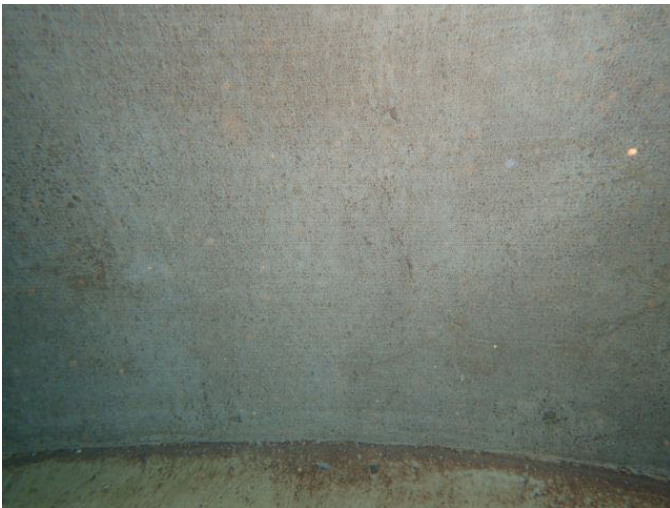
57 *Interior Wall With Mild Staining*

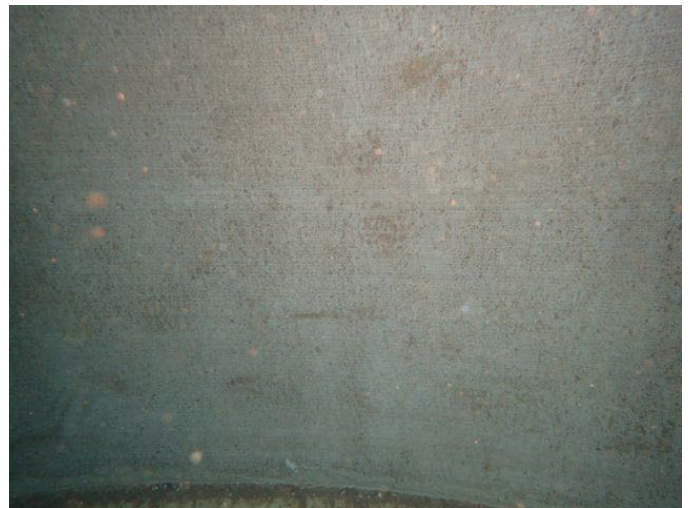
58 *Interior Wall With Mild Staining*

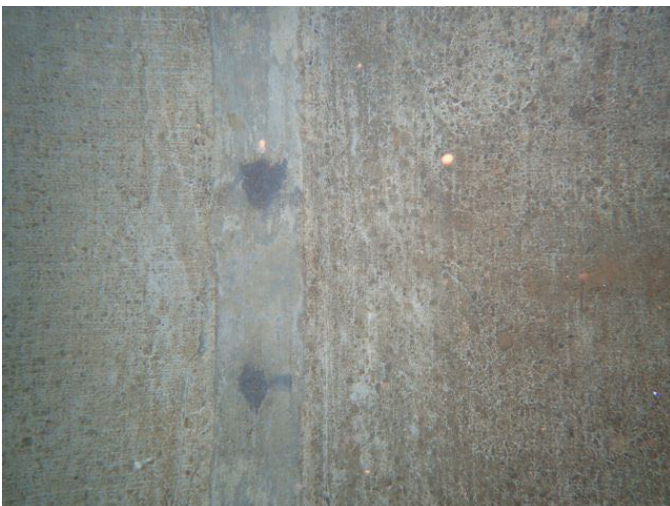
59 *Interior Wall With Mild Staining*

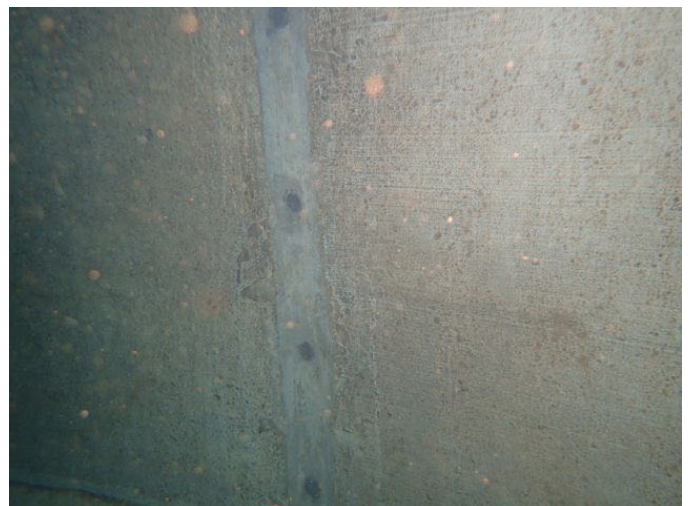
60 *Interior Wall With Mild Staining*

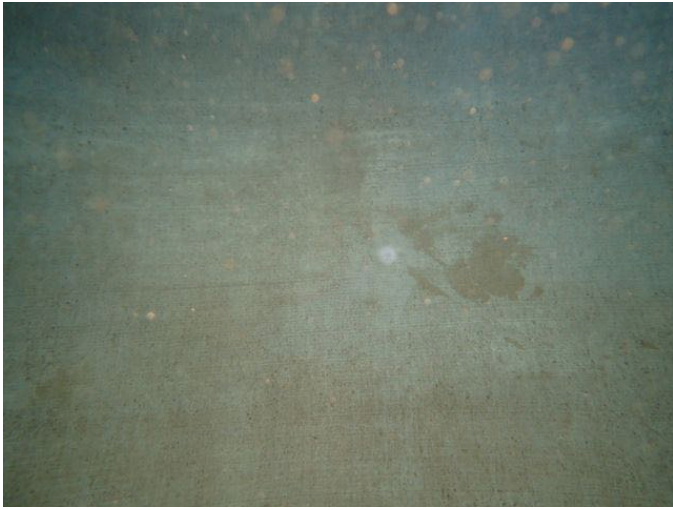
61 *Interior Wall With Mild Staining*

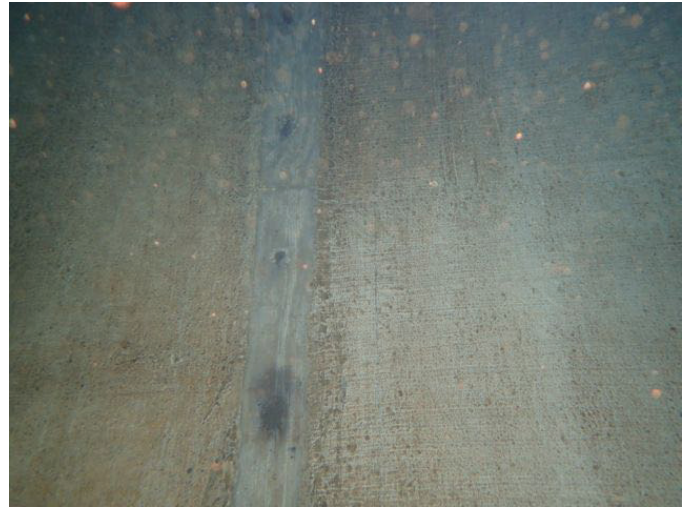
62 *Interior Wall With Mild Staining*

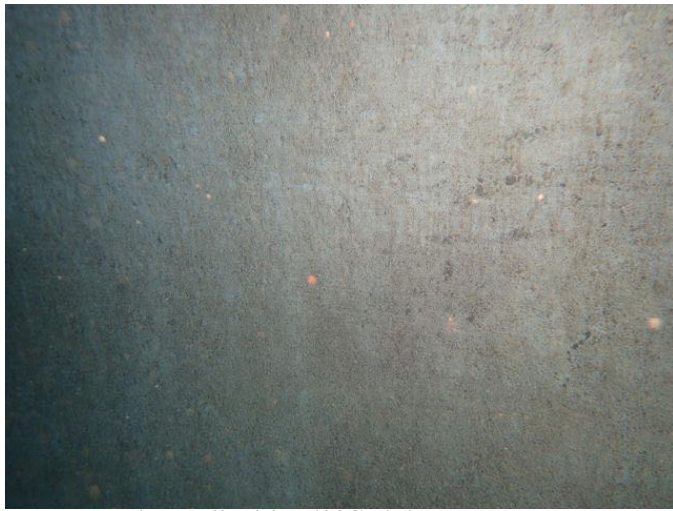
63 *Interior Wall With Mild Staining*

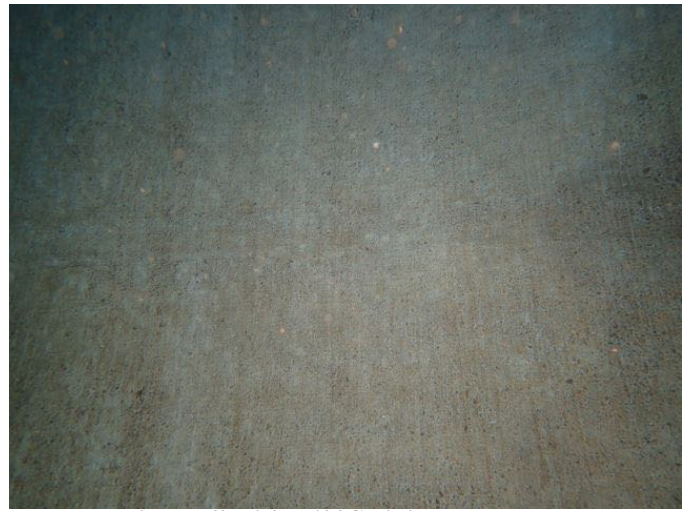
64 *Interior Wall With Mild Staining*

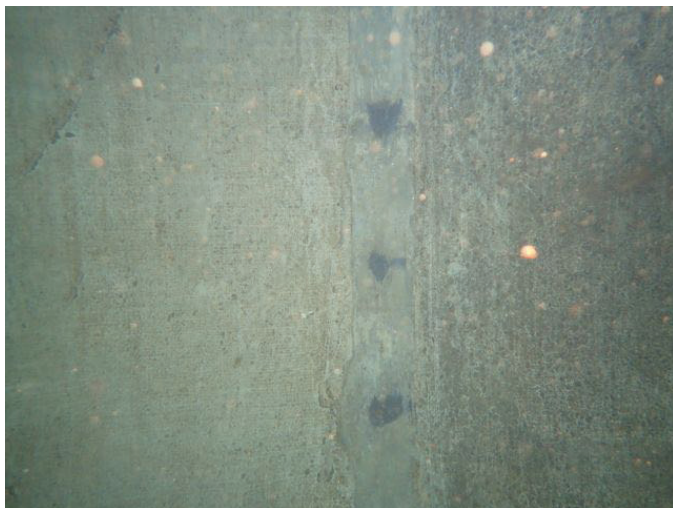
65 *Interior Wall With Mild Staining*

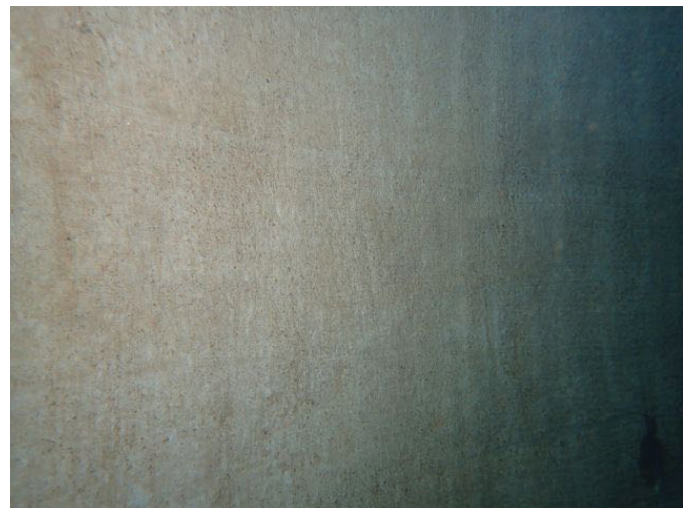
66 *Interior Wall With Mild Staining*

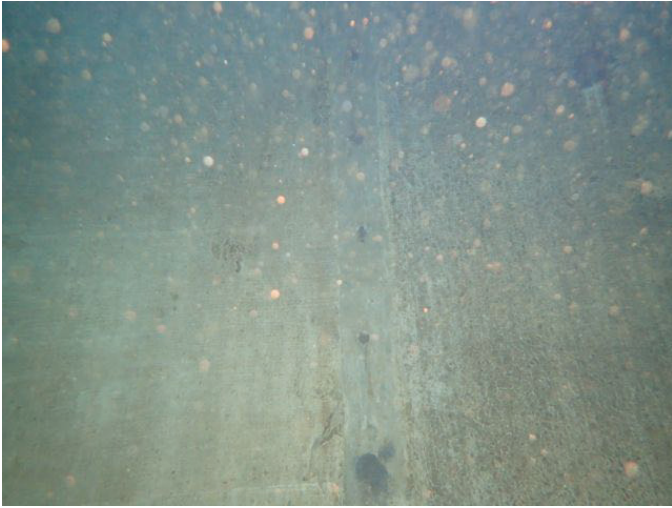
67 *Interior Wall With Mild Staining*

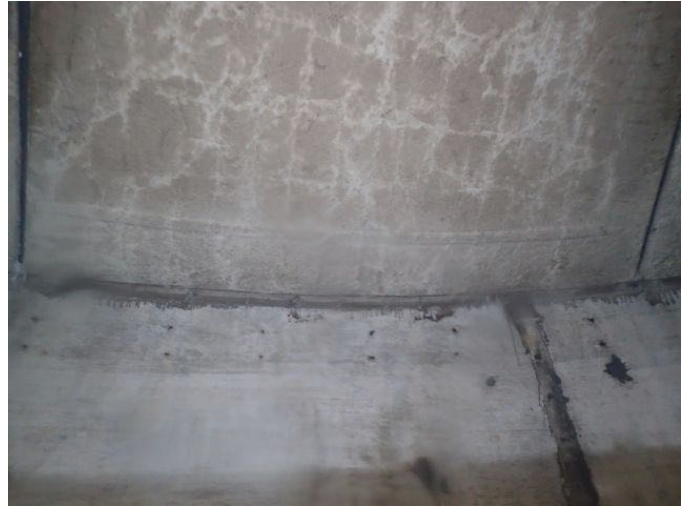
68 *Interior Wall With Mild Staining*

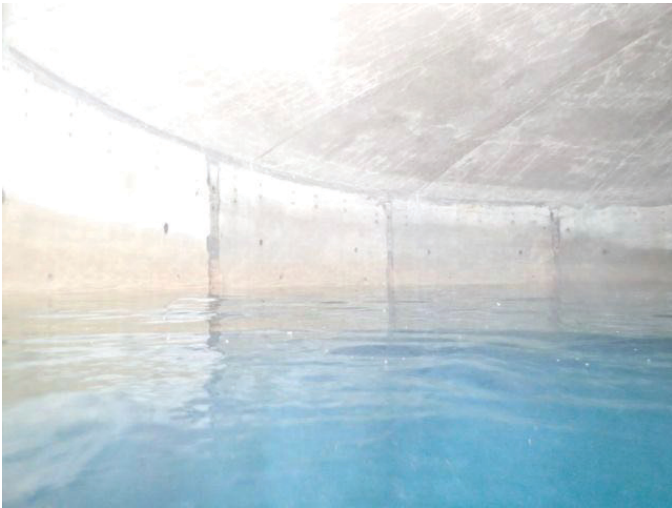
69 *Interior Wall With Mild Staining*

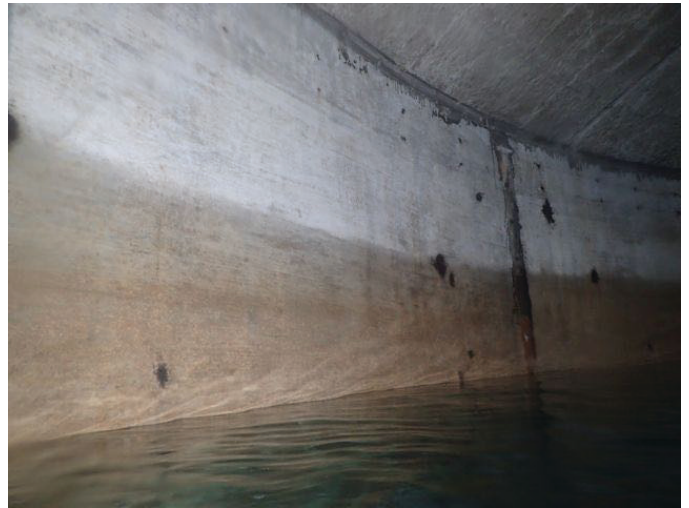
70 *Interior Wall With Mild Staining*

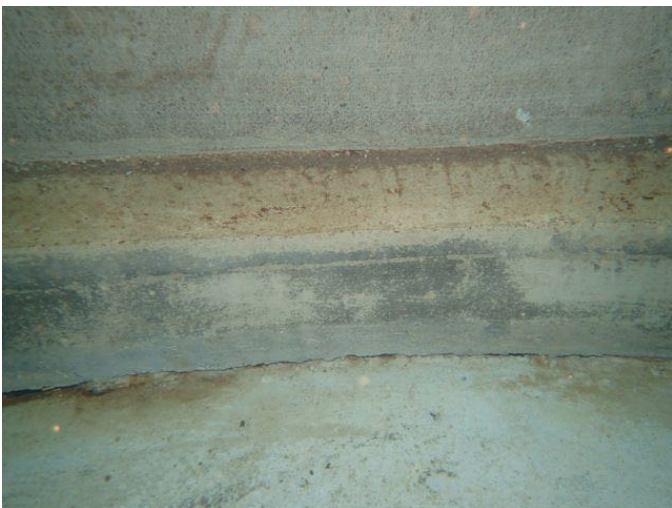
71 *Interior Concrete Curb*
